On the performance of nondestructive testing methods in the hydroelectric turbine industry

H Habibzadeh Boukani¹, M Viens¹, S A Tahan¹ and M Gagnon²

Abstract. Welded joints of turbine runners are one of the most critical parts of Francis turbines due to the presence of welding discontinuity and high stress. Because of thermal cycles, solidification, cooling distortion and residual stresses, welded joints always include discontinuities of different types and sizes. Some specific parameters will limit welding flaw dimensions in some or all direction based on the joint geometry, material and welding procedure. If discontinuities of critical size remain undetected, fatigue cracks might initiate and propagate in these zones because of dynamic in-service stresses leading to high repair costs and long down times. Therefore, reliable NDT methods and good knowledge of the probability of occurrence of welding flaws is important for fatigue life estimations. Every NDT method has its weaknesses; therefore, even after meticulous inspections it is likely for some discontinuities of critical sizes to remain in the welded joint. Our objective is to clarify the probability of detection and occurr

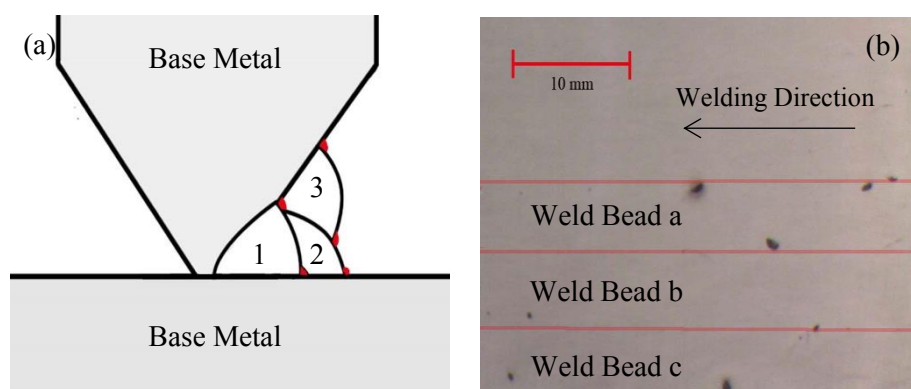
Figure 1. (a) Slag inclusions occurring in the areas of low accessibility, (b) Cross section of weld beads with slag inclusions occurring at their surfaces

The multipass welding technique used for turbine runner joints, inevitably generates some slag inclusions. Inadequate interpass cleaning of the slags of previous passes of flux-cored arc welding (FCAW) as well as inadequate heat for subsequent passes will prevent slag to reach the surface of the newly made pass generating slag inclusions in the remaining weld structure, as depicted in Figure 1. Generally, cleaning problem happens at the toe of the weld beads as a result of accessibility difficulties. Radiographic and conventional ultrasonic records will typically report the presence of some slag inclusions in the as-welded joints. Since slag inclusions may prevent the previous weld bead from being melted by the subsequent layer, some lacks of fusion (LOFs), more critical planar flaws, are also expected to occur.

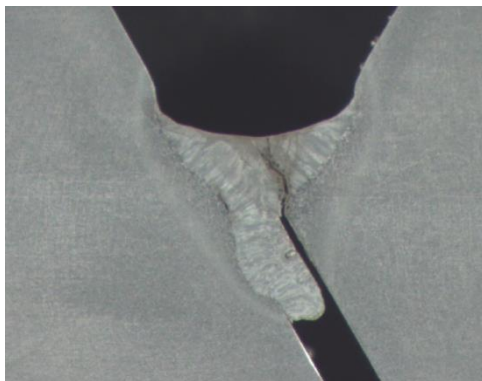
Figure 2. Subsurface cold crack profile created by Tekken test

Based on the study by Thibault et al. [5], weld metal and heat affected zone (HAZ) has roughly the same hardness; accordingly, since there is high longitudinal residual tension in the weld metal under the last weld layer, weld metal is more susceptible than HAZ to subsurface cold cracking. Although these transversal cold cracks are not oriented normal to the direction of high in-service cyclic stresses, if they are not detected by NDT methods, they may propagate leading to fatigue cracks. The propagation will then be in the direction normal to the highest cyclic working loads. It is noteworthy that heat treatment decreases the risk of cold cracking by lowering residual stress levels and the hardness of fresh martensite formed in the weld metal. An example of subsurface cold crack created during Tekken test is represented in Figure 2. Although the metal is under tensile residual stresses in the base metal and in the last layer of HAZ adjacent to the base metal, the low hardness in these areas render the occurrence of cold cracks not critical [5]. In Figure 3, we show an example of a fatigue crack which has originated from the welded joint of a Francis turbine runner.

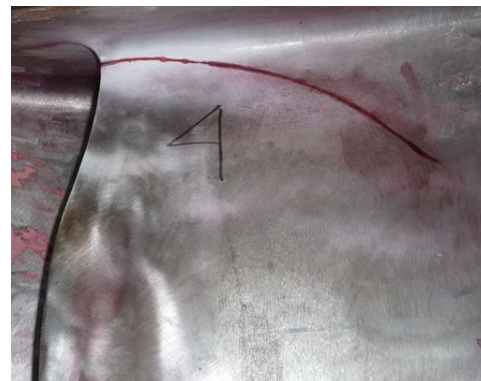
Figure 3. A fatigue crack initiated from trailing edge of blade/crown joint

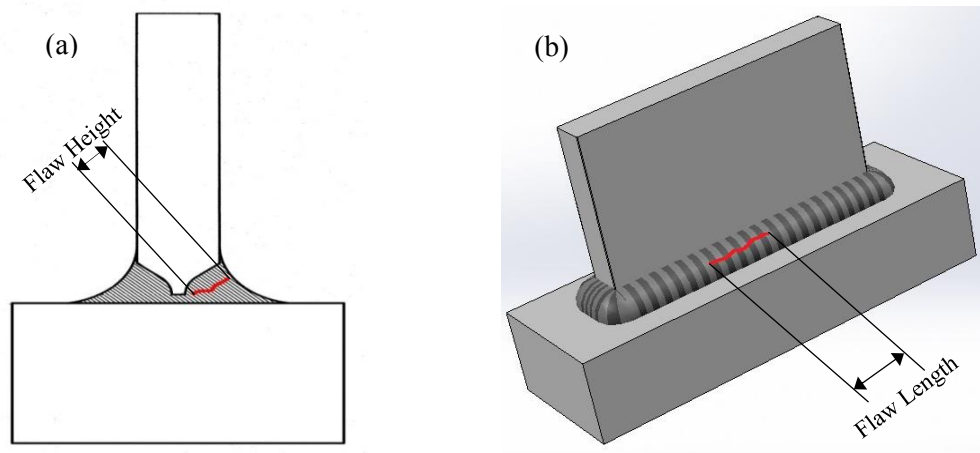
Figure 3. Flaw dimensions: (a) height, (b) length

Normally the height of welding flaws such as porosities, slag inclusions, hot cracks, lack of fusion and solidification cracking cannot be larger than the dimensions of the weld bead. In contrast, cold cracks may practically extend across several weld beads [6]. However, since there is no constraint in the longitudinal direction, welding flaws may have larger dimensions parallel to the joint axis, as shown in table 1. Notice that the distribution of residual stresses is not favourable in this direction [5, 7]; therefore, they are not expected to be prevalent. Since it is difficult to determine the height of discontinuities in turbine joints using conventional ultrasonic data, studies are more focused on finding the length of discontinuities.

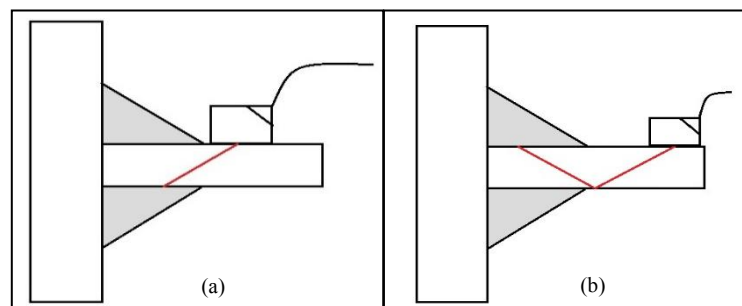
Figure 4. (a) First leg (b) second leg ultrasonic inspection.

Due to high sensitivity of ultrasonic waves to the material internal discontinuities, this is an appropriate method for detecting welding flaws. In the currently used angle beam shear wave inspection method, different beam angles have to be used in order to make sure that discontinuities with different orientations and location are detectable. If the beam angle does not have correct orientation relative to the flaw, either no indication from that flaw is reflected back to the probe or the indication is so weak that it cannot be discriminated from the background noise. Considering the limitation caused by the geometry of the runner joints, it is not possible to strike lower beam angles directly into the weld bead, as shown in a simplified form in Figure 4; therefore, the inspection pattern changes into second-leg inspection which means longer sound path and more attenuation and scattering along the path which in turn degrades the quality of received signal and decreases signal to noise ratio.

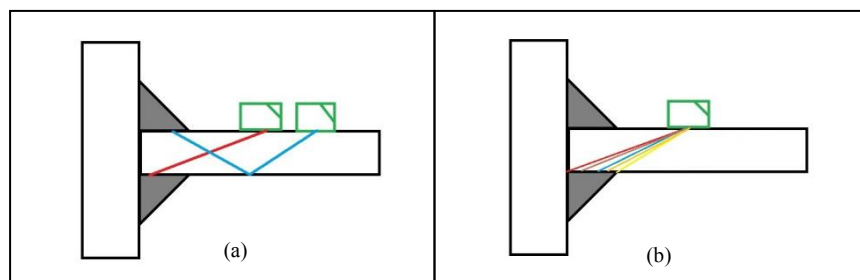
Figure 5. (a) Different beam angles on both sides required for conventional UT and (b) PAUT which covers the whole joint from one side

As stated by Anandamurugan et al. [13], PAUT technique gives better results in length sizing as compared to RT; in addition, it gives 3-dimensional data on the dimensions and location of discontinuities. More accurate sizing of the flaws obtained by PAUT leads to more reliable remaining life estimation. Furthermore, the human resources and time required for PAUT inspection is normally lower than for RT. This technique is also more efficient than conventional UT. As an example, using PAUT technique on the mock-up samples of Figure 5, the welded joint of the turbine runner can be inspected from one side while using the conventional UT technique the full coverage of weld can only be obtained by applying the 45 and 60 degree probes from one side and the 70 probe from the other side. Moles [14] mentions that for T-joint inspections where multiple shear wave angles are necessary, early investigations showed that PAUT is 5 times faster than conventional manual UT; besides the operator's interpretation of a waveform is no longer such a key factor. Notice that the results of PAUT can be recorded and saved to be interpreted later reducing the human error.

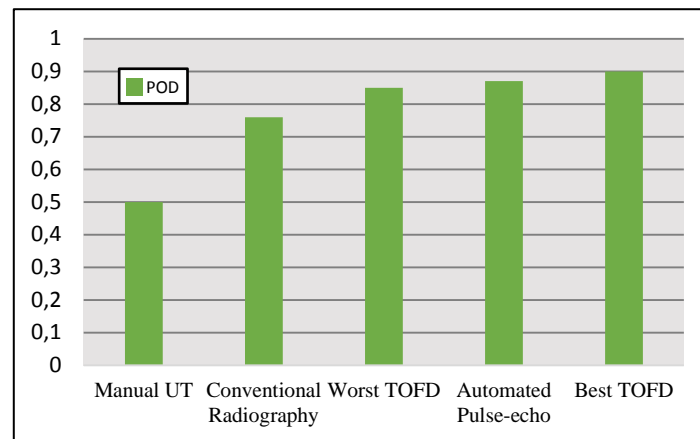
Figure 6. Improvement of inspection capability of steel welded plates by eliminating the human factors (data taken from [15])

Basically using automated inspection process instead of current manual UT would reduce the effect of human factors and working environment leading to improvement in accuracy and POD [15]. Automatization is sometimes not economical due to its costs. Nonetheless, the costs can be sometimes compensated by better POD and lower probability of false indication (POFI), see Figure 6. Lower POFI means lower repair costs and less downtime for repairing false indications [16]. In order to compare quantitatively two NDT techniques, laboratory studies on mock-up samples have to be carried out. In such cases, there is always some discrepancy between the capability of laboratory and real in-site inspection. These differences should be lower for automatic inspection since the environment and human factors are less significant.
