# Accurate determination of damaged subsurface layers in machined Inconel 718

## Abstract

Machining; microstructure; subsurface layers; damages; microhardness; deformed layer.

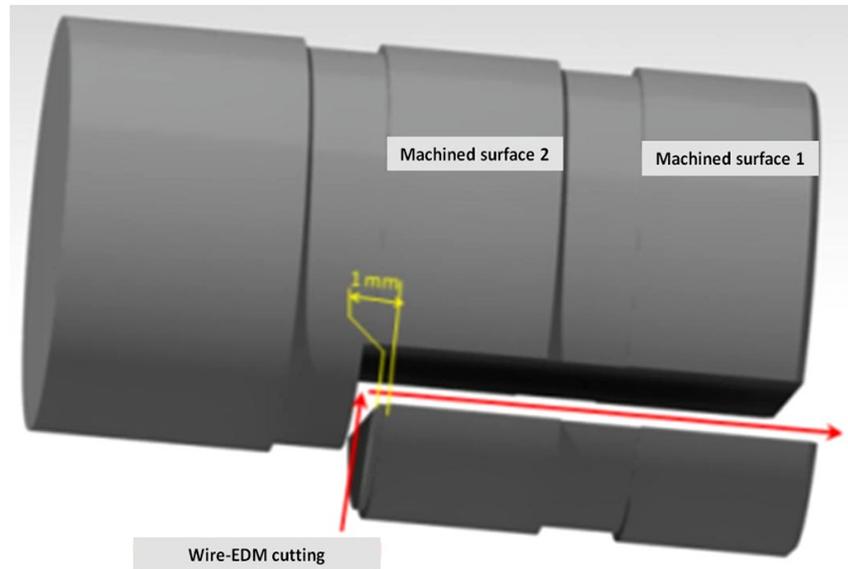
Fig. 1 Wire EDM cutting of the machined surfaces

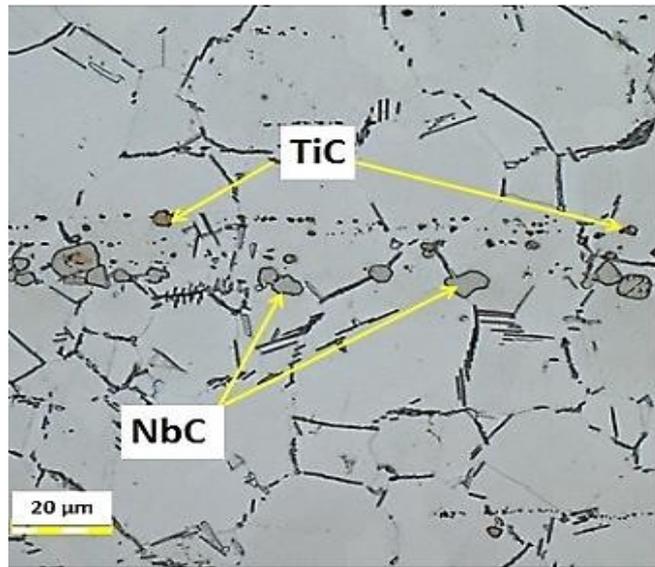
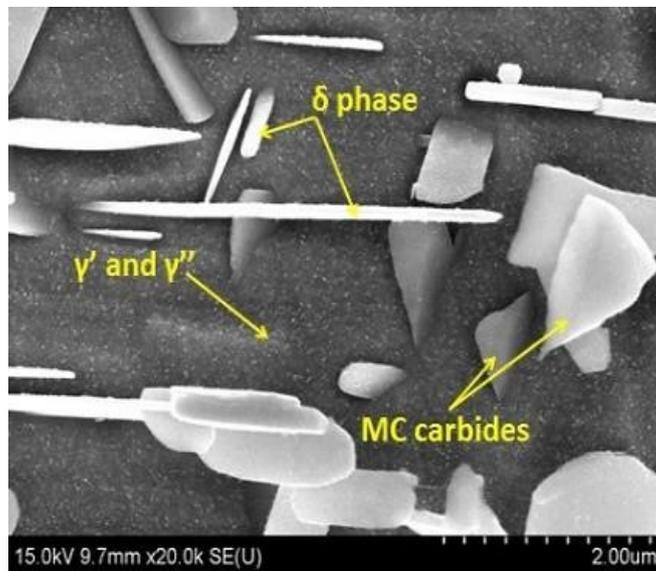
Fig. 2 Microstructure of Inconel 718: (a) optical microscope and (b) electronic microscope

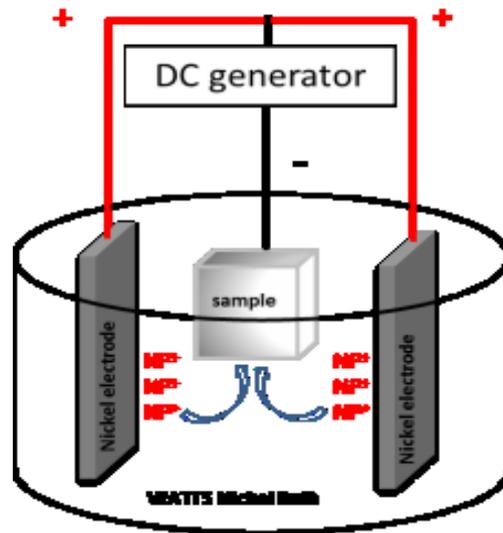
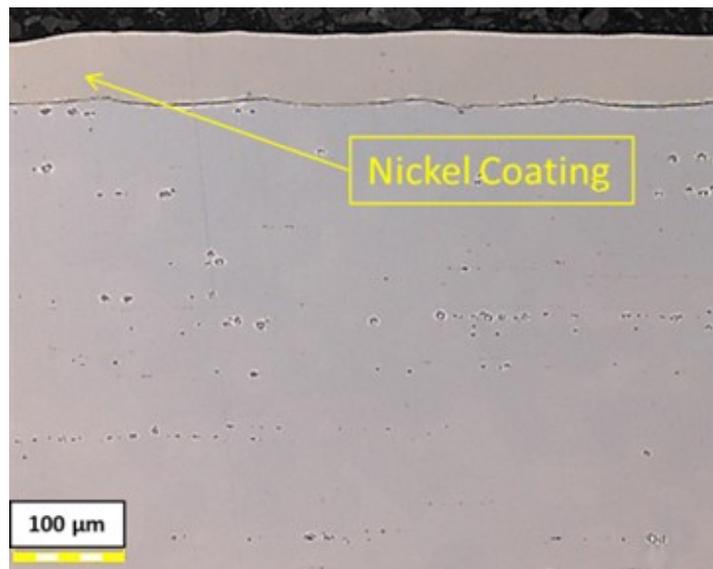
Fig. 3 Nickel coating method: (a) Nickel coating device (b) Nickel coating performed layer

A layer of nickel was deposited on the machined surface using nickel electrodes, a DC generator and a Watts solution as shown in the Fig. 3 (a). The coating parameters were optimized in order to achieve a 100  $\mu\text{m}$  thin layer, as it was found that thickness below 100  $\mu\text{m}$  was not sufficient in holding on the machined surface during the mechanical polishing

stages. The optimum coating parameters were determined to be 3 mA/dm<sup>2</sup>, 1 hour and 45°C of current density, coating time, and temperature, respectively. Throughout the study, both the cutting (perpendicular to the feed direction) and feeding directions (parallel to the feed direction) were coated with the 100 µm nickel layering and analyzed in both directions as shown in the Fig. 3 (b). It must be noted that the optimum conditions also allowed producing very fine nickel particles that took the form of the surface very precisely, thereby covering and protecting even very small defects.

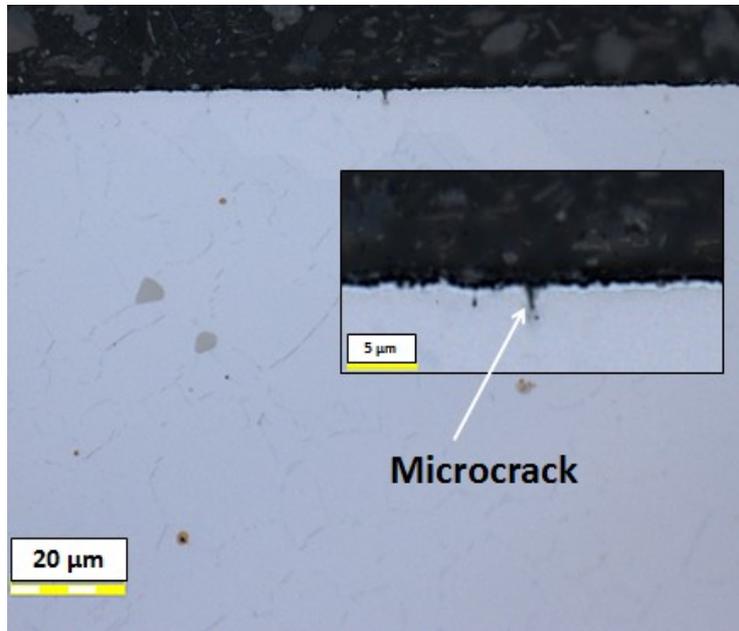
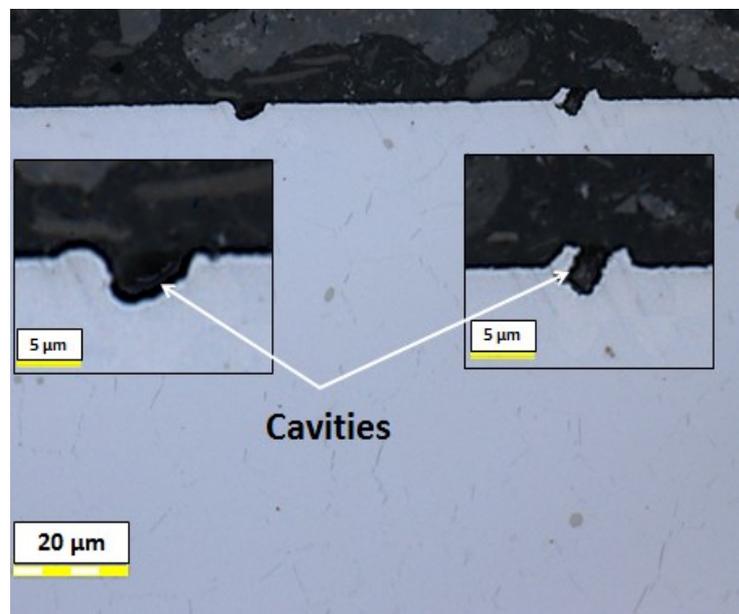
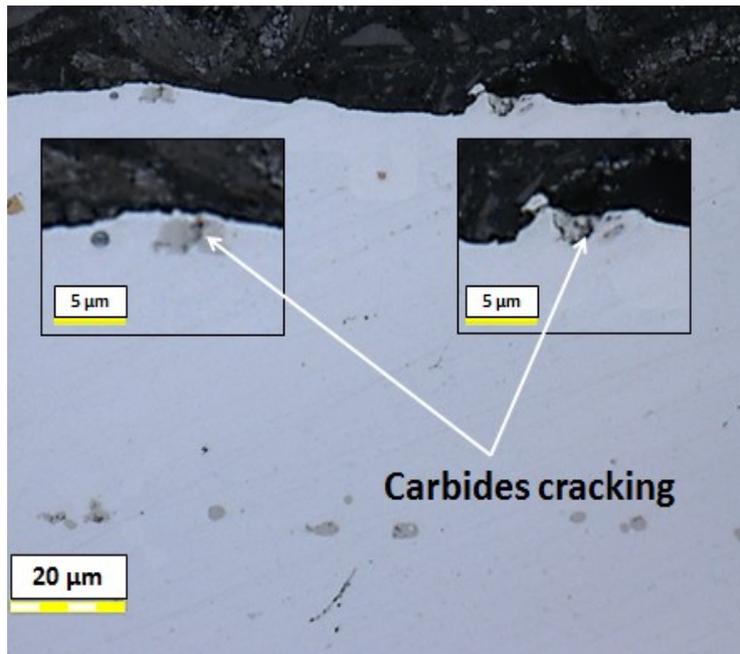
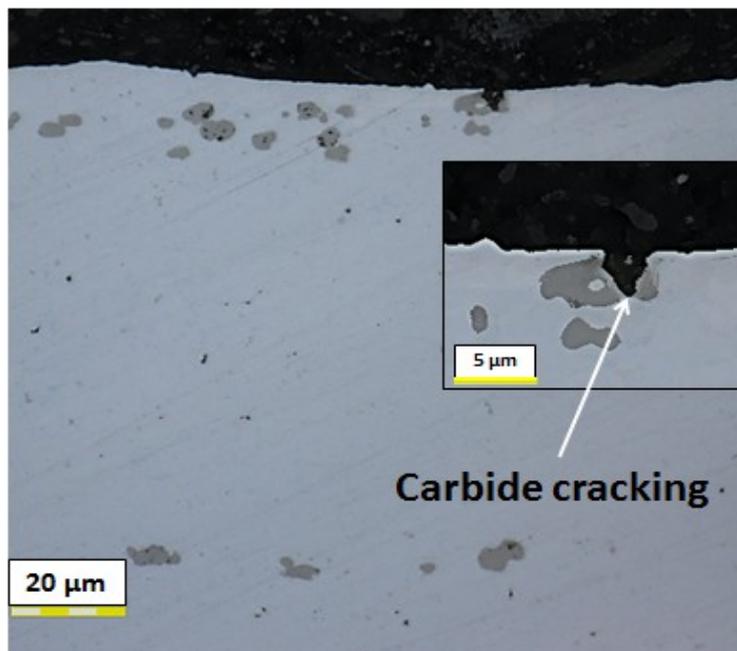
Fig. 4 Typical polishing defects and zooms related for the test A: (a), (b) following the cutting direction and (c), (d) following the feed direction

Major defects can be found on the surface prepared with no nickel coating as revealed in the images in Fig. 4, where defects can be observed along both cutting and feeding directions. The samples prepared with the protective nickel layer did not display such a large quantity of defects as shown in the Fig. 5 (a), (b), (c) and (d). Defects due to sample preparation originate from the effect of the force applied to the sample edges during polishing which may result for example, in carbide detachment and ultimately to microcracks.

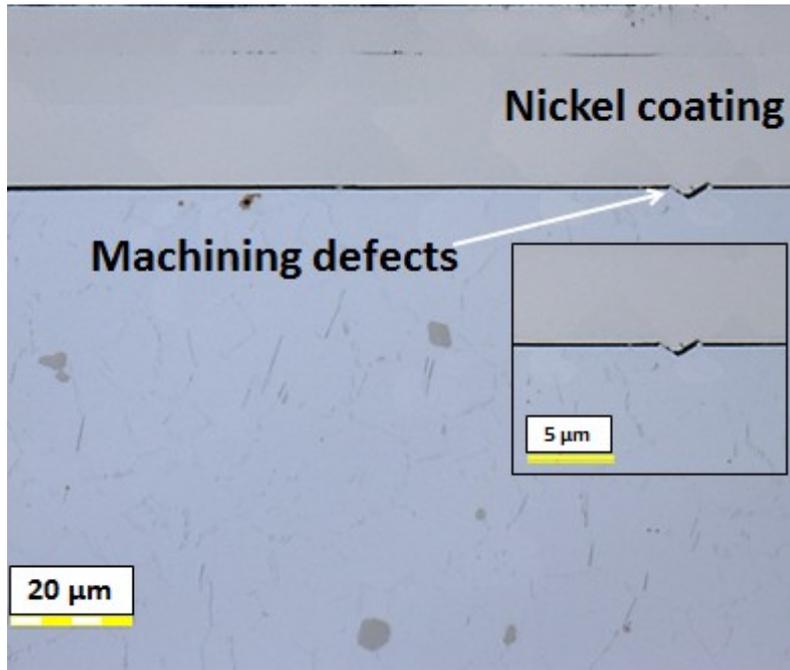
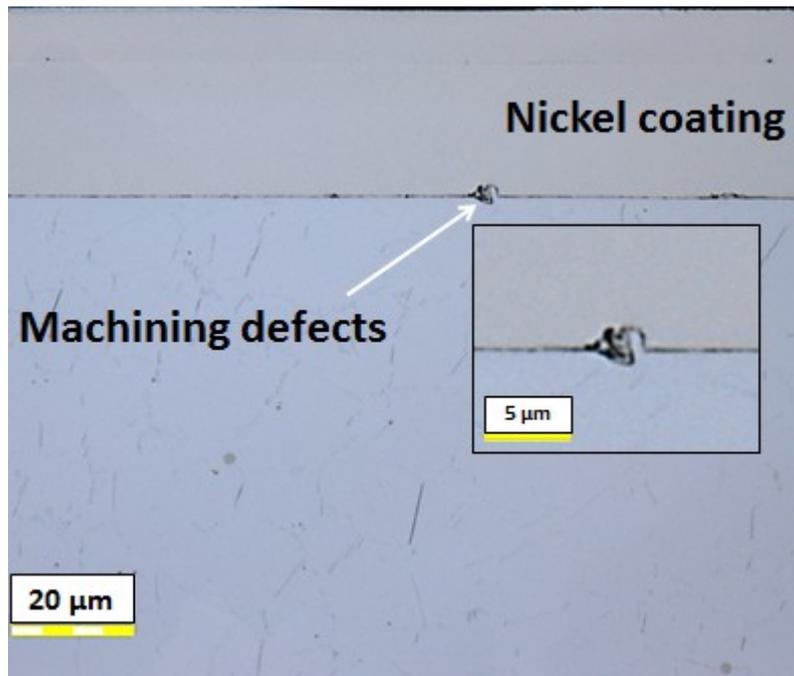
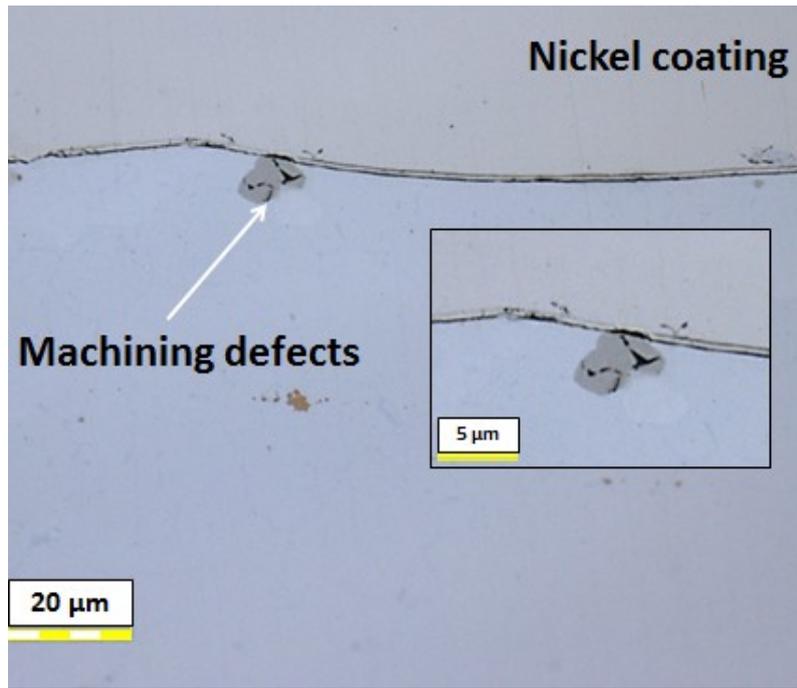
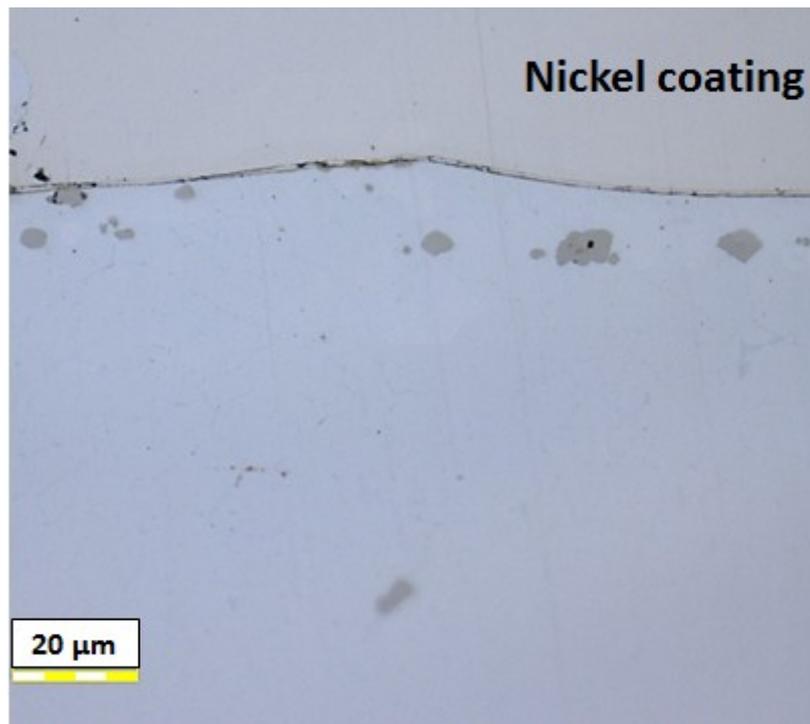
Fig. 5 Machining defects and related zooms: (a), (b) following the cutting and (b), (c) following the feed direction

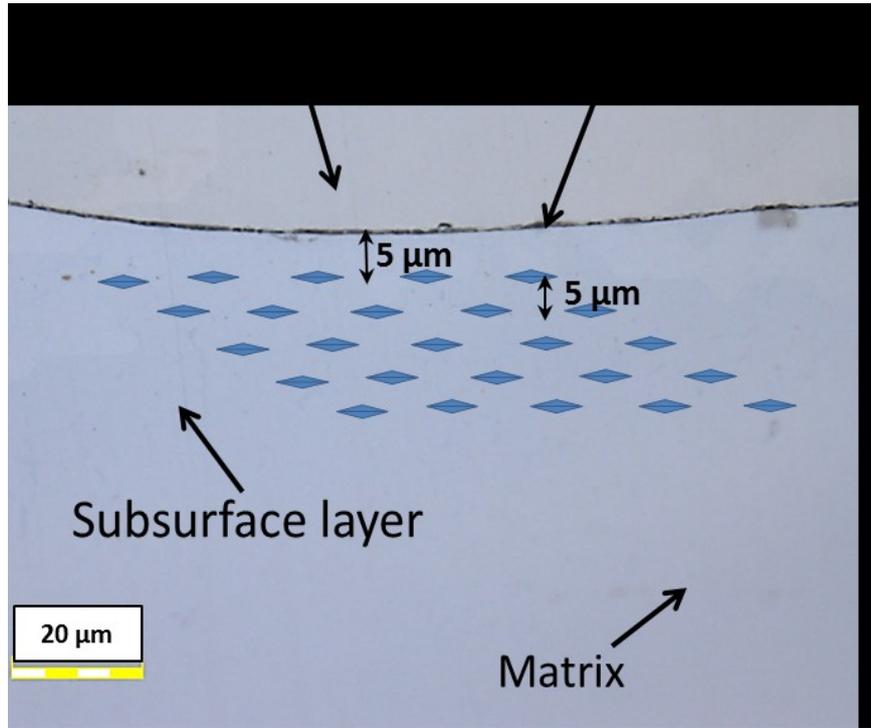
Fig. 6 Method used to characterize the softened layer using microhardness measurements

In order to test the effect of surface protection on microhardness, Knoop microhardness matrix was performed as shown in the Fig. 6 on coated and uncoated surfaces machined under similar conditions. The measurements were applied on a cross section and followed the feeding and cutting directions from the affected surface to the bulk material. The indentations were applied at a distance of about 5±1 µm from the nickel coating. Three zones can be identified from the hardness profiles: a hard layer (zone 1); a soft layer (zone 2); and a region with significant variations and average values typical of the matrix (zone 3). The microhardness evolutions beneath the machined surface are represented in Fig. 7. It can be seen that hardness drops in the first 10 µm for the cutting direction and in the first 15 µm following the feed direction. In addition, microhardness values are always higher in the cutting direction than in the feeding direction. The thickness of the soft layer is about 23 µm in the coated samples. This finding confirms that polishing operation without protecting the sample with an appropriate coating can introduce defects in the machined surface and particularly in the first few microns. These defects can relax compressive residual stresses and decrease hardness in the subsurface regions very close to the machined surface layer. In addition, polishing can deform the subsurface, about 10 to 15 µm beneath the machined

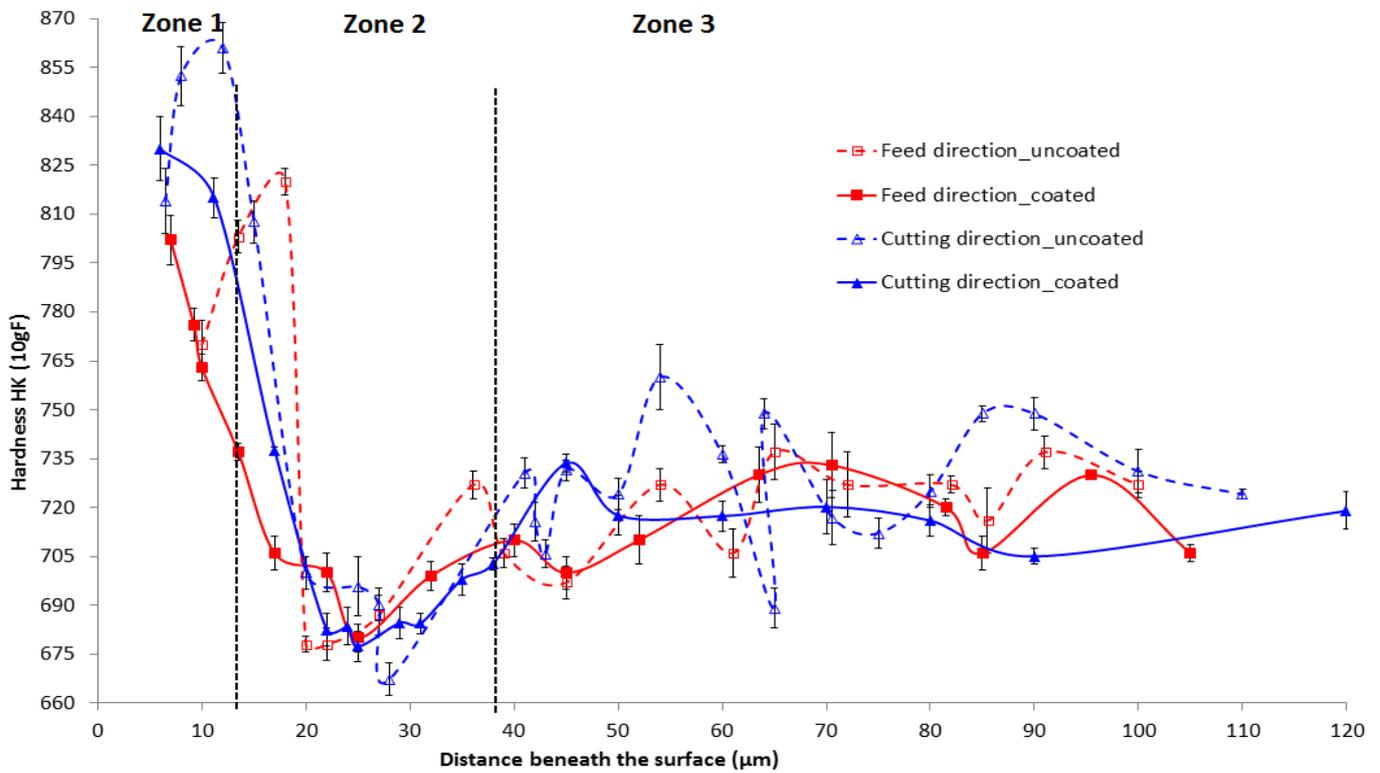
Fig. 7 Effect of the protective nickel coating on the values of microhardness beneath the machined surface for the test A

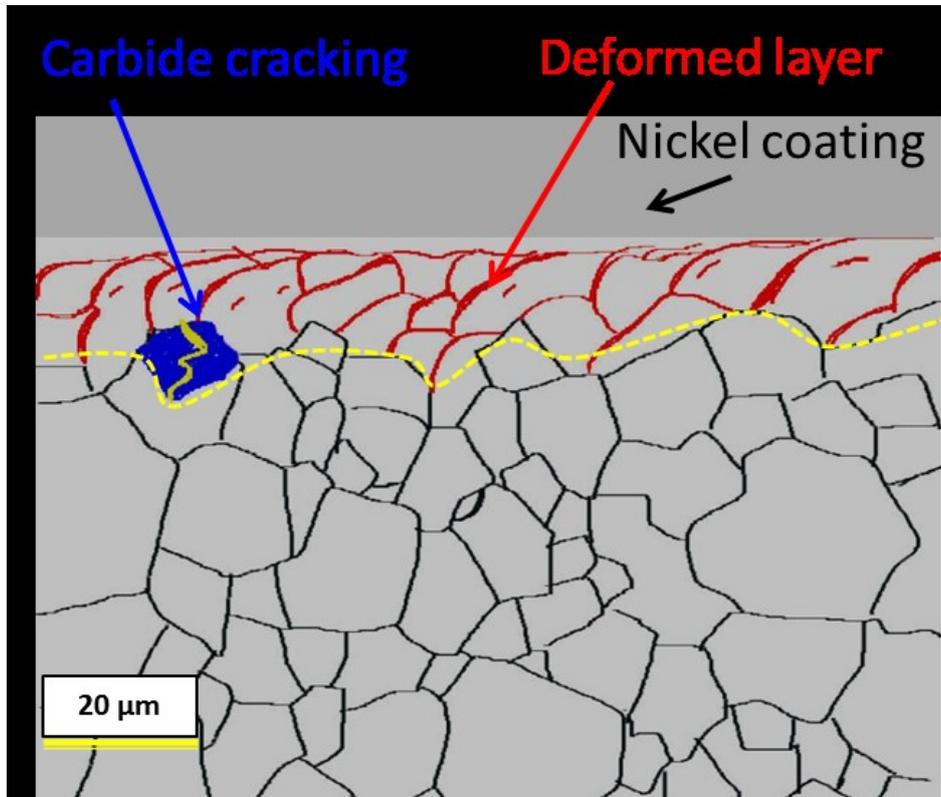
Fig. 8 Method used to characterize the depth of deformed layer using laser microscope

Confocal microscope was used to measure the thickness of the deformed layer from the surface to the last distorted grain boundary and to the last defect as presented in Fig. 8. In

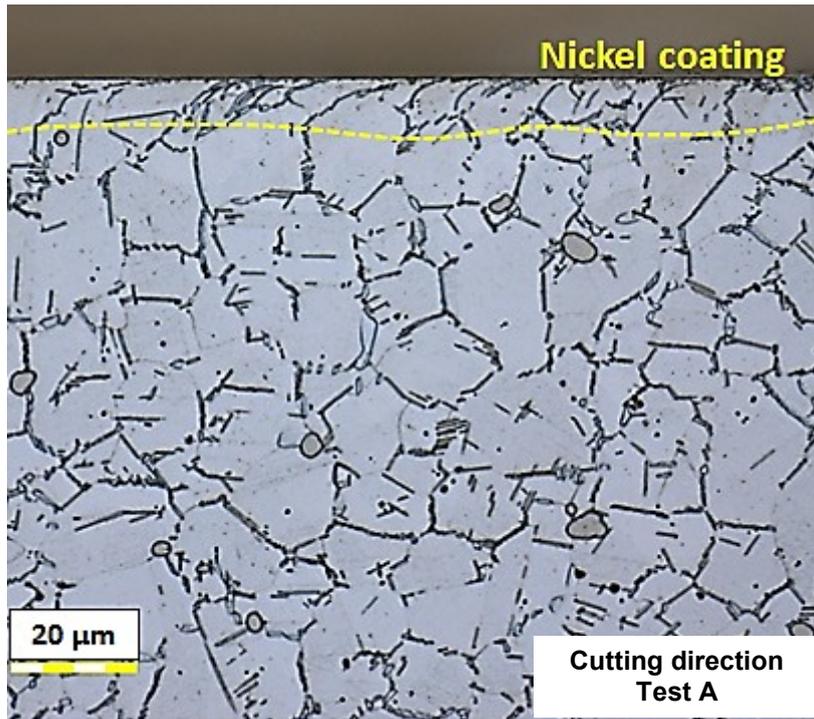
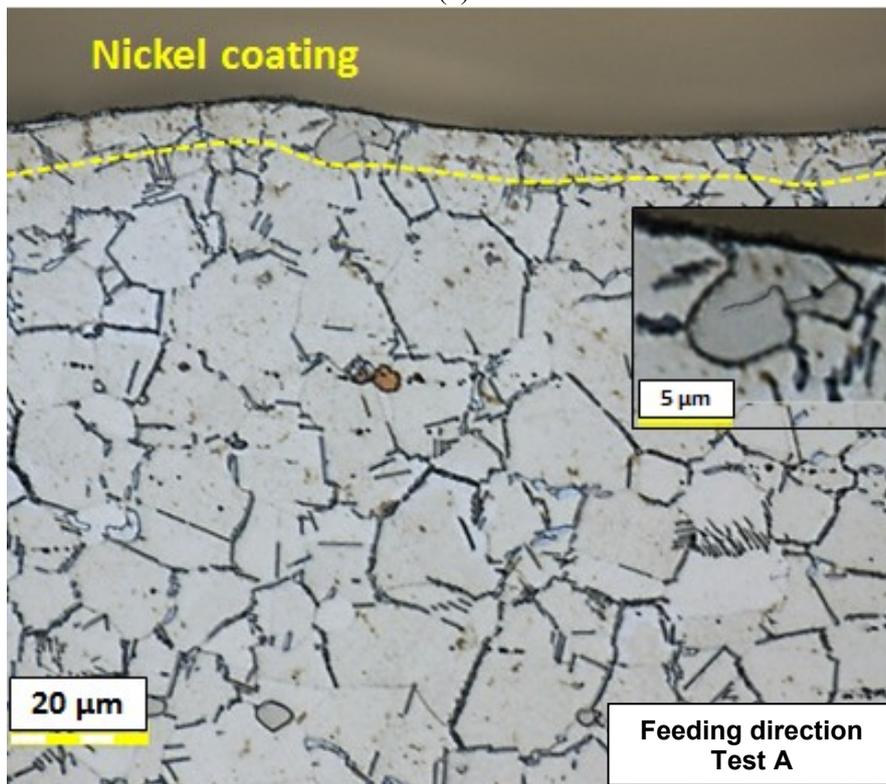
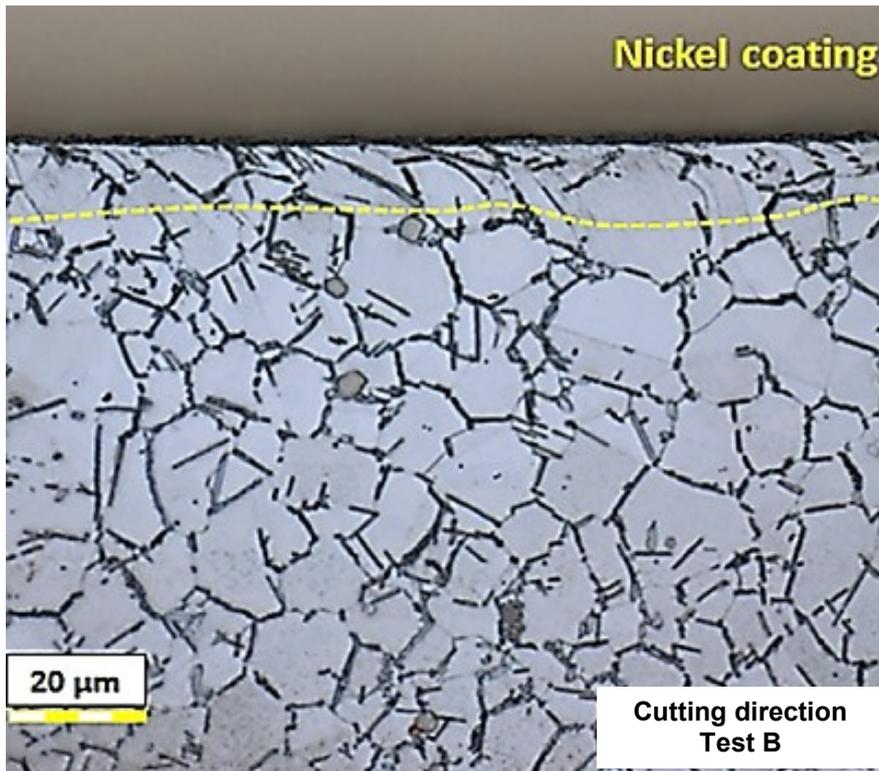
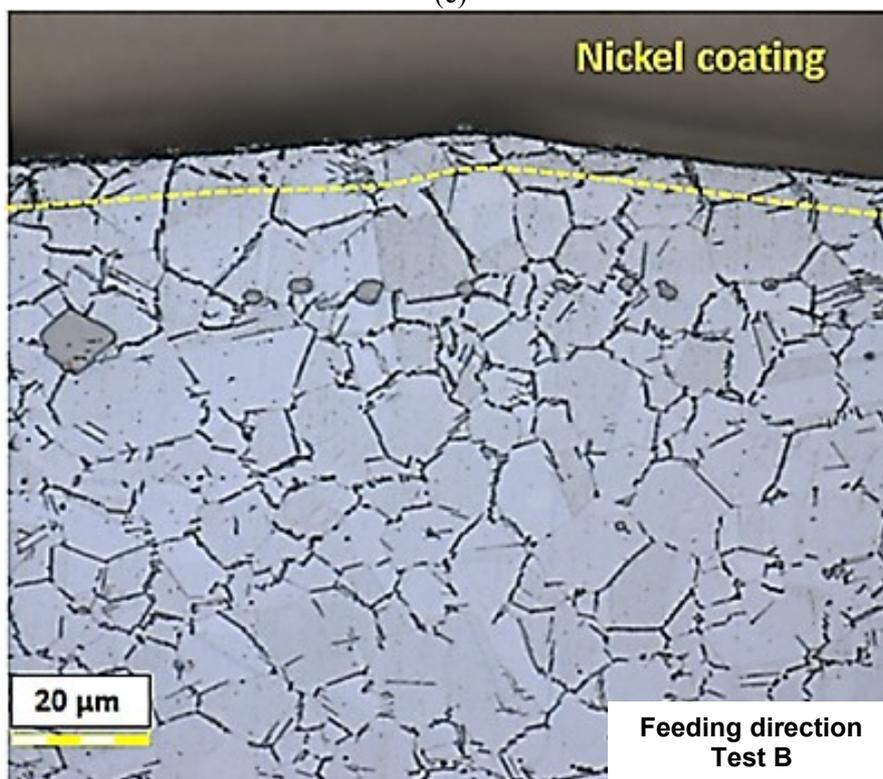
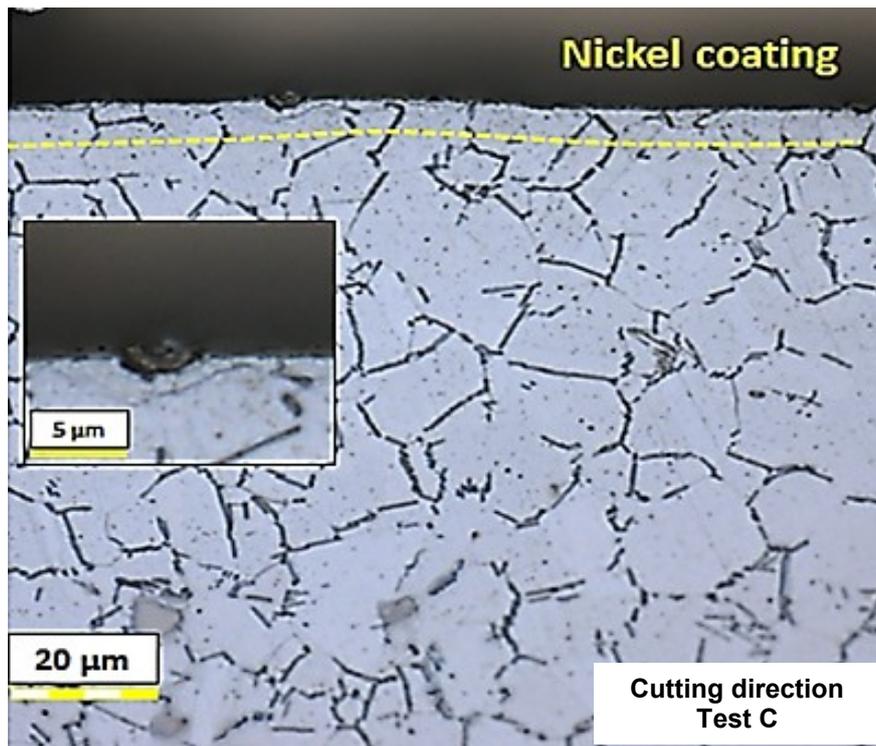
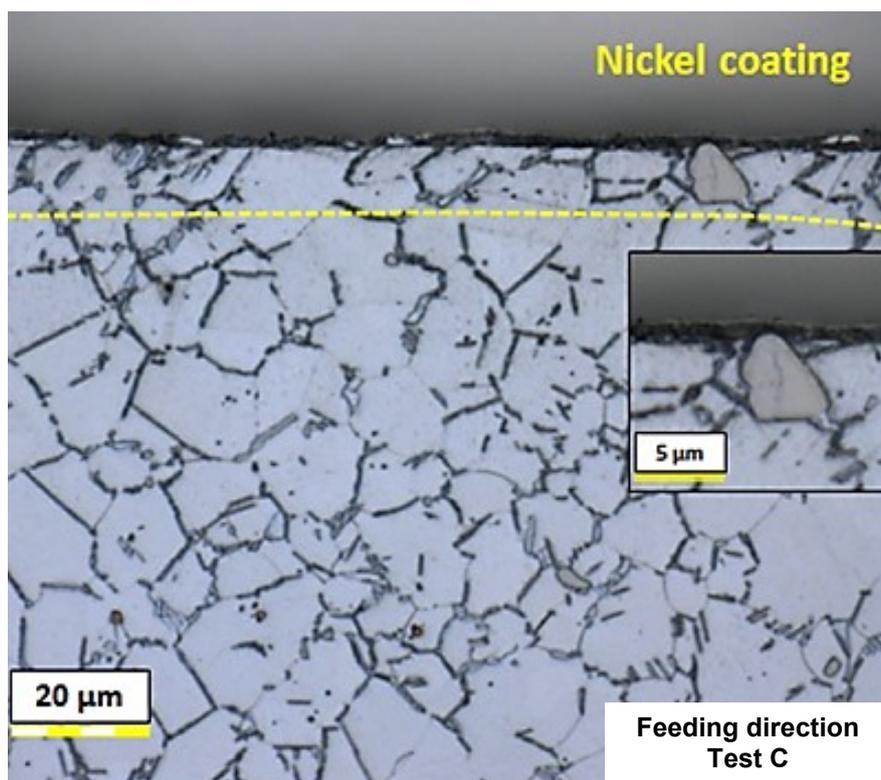
Fig. 9 Localisation of the deformed layers for the different tests: (a) cutting direction test A, (b) feeding direction test B, (c) cutting direction test B, (d) feeding direction test B, (e) cutting direction test C and (f) feeding direction test C

order to have accurate results and a significant statistical analysis, at least 15 images at a magnification of 1000X were used for each machining condition. All values are presented with a confidence interval of 95% in Table 3. The analysis of the obtained data shows that the thickness of deformed layer is different from both cutting and feeding directions, as displayed in the images for tests A, B and C in Fig. 9 (a) to (f).

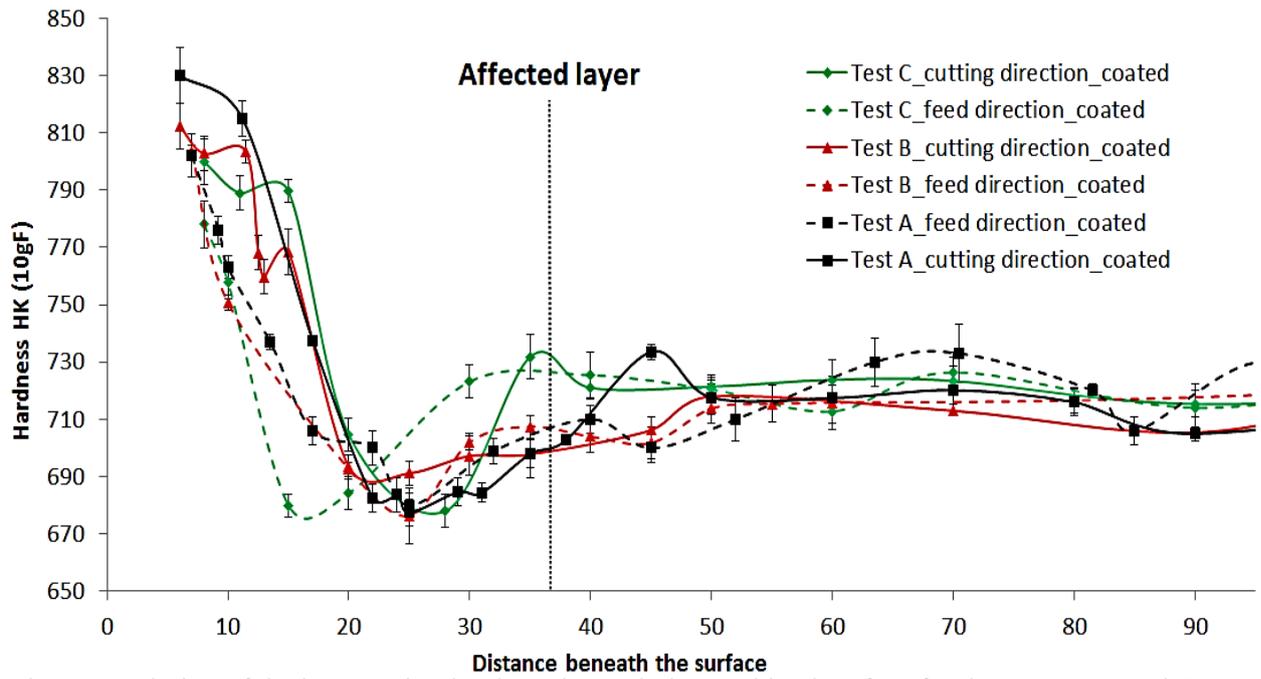
Fig. 10 Evolution of the knoop microhardness beneath the machined surface for the tests A, B and C: Dashed lines (feeding direction) and continuous lines (cutting direction)

The influence of machining conditions on the surface layer was quantified using the coated samples. The cutting and feed direction hardness profiles from the three selected cutting conditions are shown in Fig. 10 and the summary of the measured values from these graphs are reported in Table 3. For all conditions, it is confirmed that hardness is higher in the cutting direction than in the feed one. The hardness values following the cutting direction are higher than in the feed direction. This ascertainment could be explained as follows: As shown in Fig. 6, first, the feed marks caused by the tool during machining are visible along the longitudinal section of the machined sample (i.e. feed direction). The distance between two feed marks' vertices is about few micrometers and it can be seen that the hardness at the bottom of the feed mark is higher than at its top. This is due to higher stress concentration and therefore more distortion in these regions (compare Fig. 9 (a), (c) and (e) with 9 (b), (d) and (f)). In contrast, in the cutting direction, which represents a cross section, it is not possible to distinguish the feed marks' vertices because the thickness of the abrasive cut-off wheel (few millimeters) is much higher than the distance between two vertices. Therefore, when measuring hardness in the feed direction, the obtained value will be a combination of the bottom (high hardness) and top (low hardness) regions of the feed marks resulting in a lower average value for the hardness in the cutting direction. Relative to the average matrix's hardness, the maximum hardness were found to be about 115 HK higher, whereas the minimum ones were 43 HK lower. The maximum hardness varies significantly from one cutting condition to the next (from 778 to 830 HK) while the lowest values stay quite similar

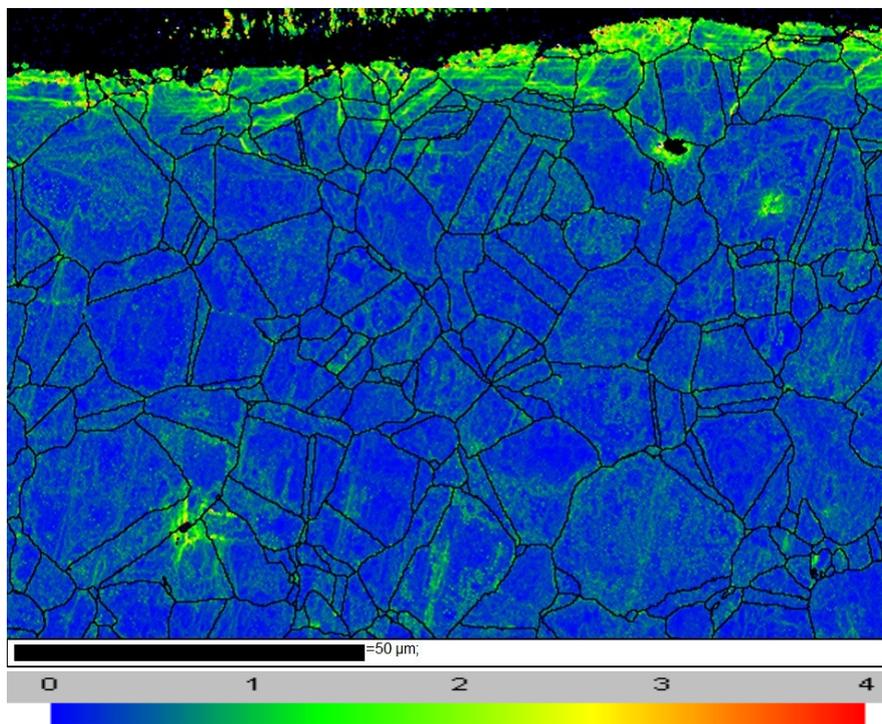
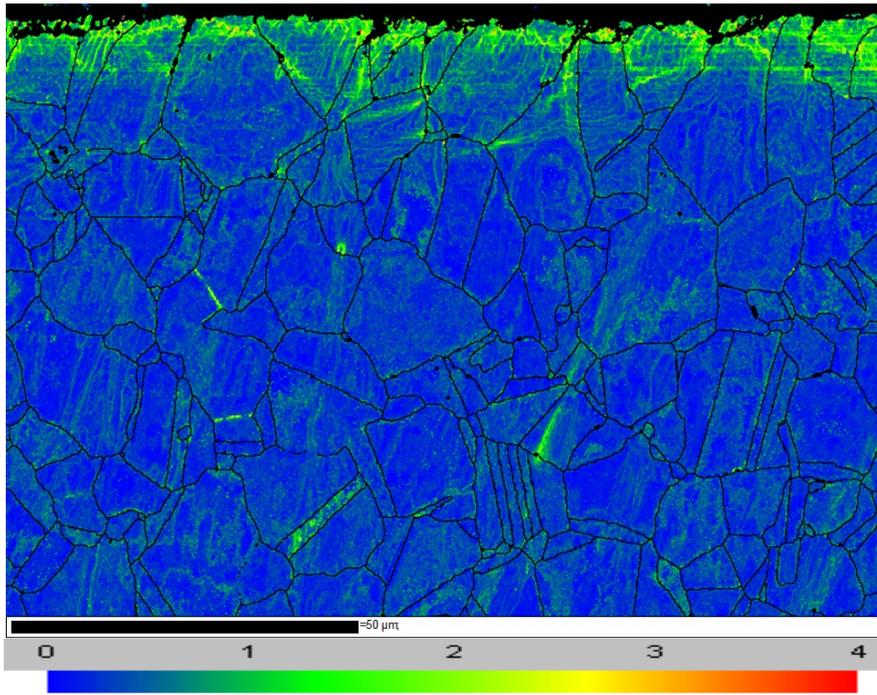
Fig. 11 Local misorientation in the surface and subsurface layer for the Inconel 718 machined for the test A: (a) following the feeding direction, (b) following the cutting direction. An area in green and red are highly deformed ( $2^\circ$  or more), and an area with low deformation is in blue

In order to further study the limits of the deformed zones, EBSD maps were performed close to the edge of the machined surface. Full indexation was obtained for samples with the nickel coating allowing grain misorientations in the range of 1° to 7° to be displayed as illustrated Fig. 11 on the samples processed in test condition A. They are localized in a deformed layer with a thickness of around 7.8 μm and 11.9 μm following the feed and cutting direction, respectively. The results are consistent with the measurement of the deformed layer made by laser confocal microscope (6.3 μm and 10.5 μm, respectively). It is also worth noting that in addition to revealing the deformed layer, the misorientation maps obtained from EBSD reveal that significant deformation are present further below the surface around carbides or twin boundaries. This is a confirmation of the particularities of these microstructures which are known to accumulate deformation in a strain field which will become potential fatigue nucleation sites [25-27].
