## Corrosion failures of flanged gasketed joints: A review

Soroosh Hakimian, Abdel-Hakim Bouzid, Lucas A. Hof\*

### ABSTRACT

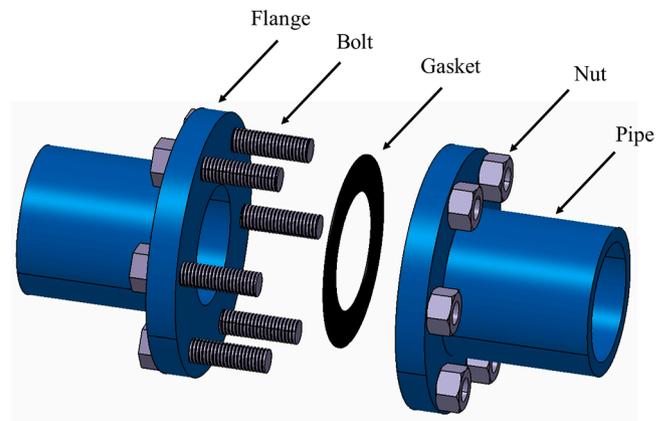
Fig. 1. Schematic of a bolted flanged joint with a gasket placed between two flanges, and tightened by bolts.

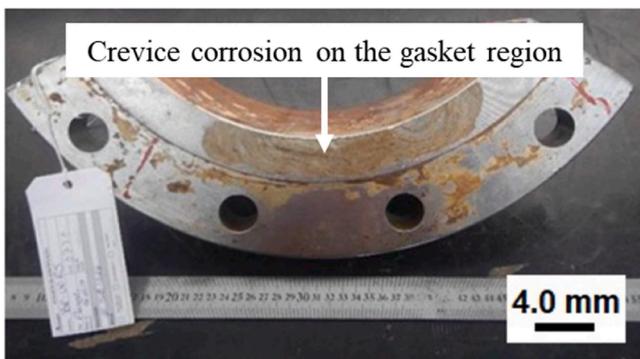
Fig. 4. Crevice corrosion observed on the UNS S32760 SDSS flange face in the gasket region<sup>1</sup> (Kölblinger et al., 2022).

UNS S32760 super duplex stainless steel (SDSS) that was in contact with the gasket (Fig. 4). There has been five years of operation of the flange line, running under a pressure of 1.14 MPa on the top side of an oil platform with seawater at 28 °C on average (Kölblinger et al., 2022). Tavares et al. (2018) reported premature failure of a SS (UNS S32750) flange due to pitting corrosion and cracking (Fig. 5), which was operated with seawater at 40 °C and 0.1 MPa of pressure in a discharge water line of an offshore platform.

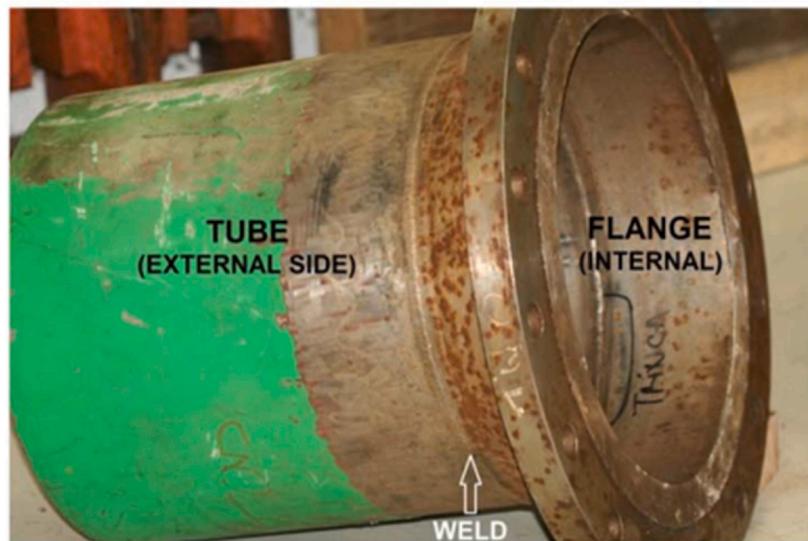
Fig. 5. Flange failure due to severe internal pitting corrosion and circumferential crack, visibly marked by a black line on the internal side of the flange<sup>2</sup> (Tavares et al., 2018).

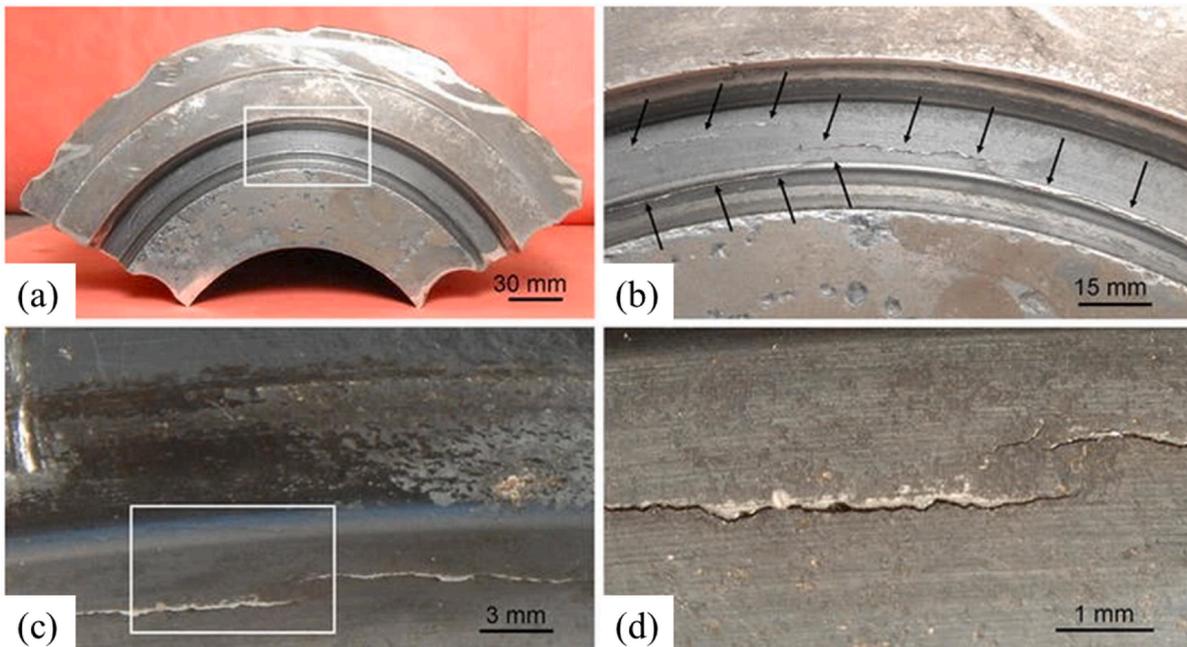
Fig. 6. SCC on the flange RTJ (a) An area of the flange RTJ with a crack, (b) a magnified image (a) where multiple cracks are shown, (c) multiple cracks joining together, and (d) a close-up view of (c)<sup>3</sup> (Gore et al., 2014).

Gore et al. (2014) studied the failure of a flange used with ring type joint (RTJ) that was part of the reactor pipeline of a hydrocracker unit. Following a periodic shut-down of the unit, cracks were observed on the flange grooves and RTJ gaskets (Fig. 6). At the time of failure, the hydrocracker had been in service for approximately 11 years. RTJ gaskets were manufactured from stabilized grades of austenitic SS, specifically type 321 and type 347. Further investigations revealed that the RTJ gaskets failed due to trans-granular stress corrosion cracking (SCC). This cracking was initiated by the formation of polythionic acid resulting from the presence of H<sub>2</sub>S in the process gas, combined with the presence of H<sub>2</sub>O within the system. Based on empirical evidence, it was suggested that the hydrocracker unit was improperly shut down during the last maintenance, which allowed O<sub>2</sub> and H<sub>2</sub>O to enter the system.

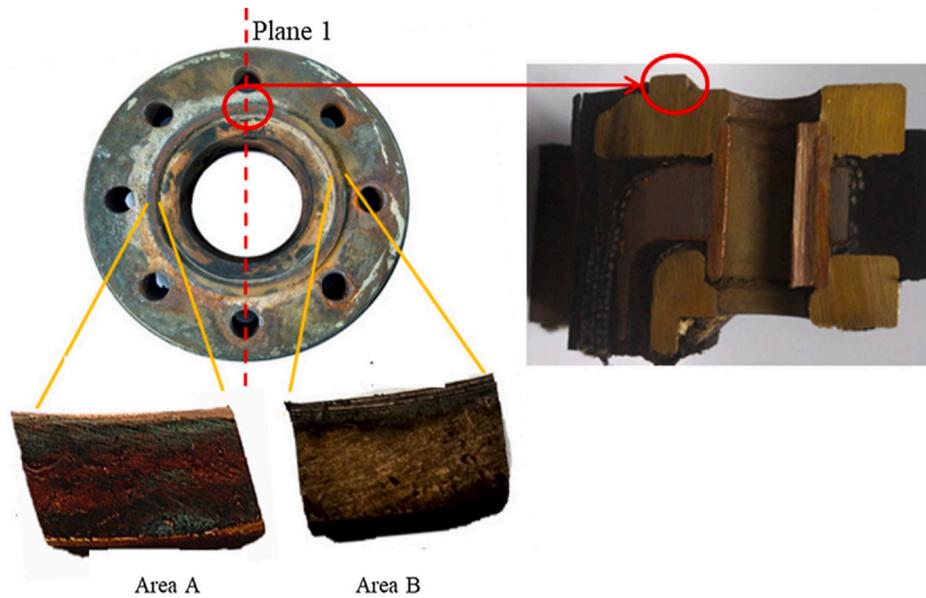
Fig. 7. Corroded surface of a copper flange highlighting two distinct corroded areas labeled A and B. The red dashed line indicates the position of the convex flange's cross section<sup>4</sup> (Hu et al., 2020).

Hu et al. (2020) investigated a corroded copper flange that caused leakage in a diesel engine cooling system in less than one year of service. A Monel spiral wound gasket filled with PTFE was used with the copper flange. The chemical composition analysis showed that the base material of the flange contained 69.7 % Cu and 28 % Zn. As shown in Fig. 7, the corroded surface of the flange has a red ochre color (area A), and a yellow ochre area (area B). The authors took samples from these two areas and did a chemical analysis. Based on the results, in the red ochre area, the content was 86 % Cu, and 3.61 % Zn, while in the yellow ochre area, the content was 55.27 % Cu and 39.20 % Zn. This indicates that dezincification corrosion occurred more in the area A than area B. Due to the dezincification corrosion, pores are formed on the flange surface, the PTFE coating on the Monel insert is not enough thick to fill in the pores due to the limited deformation; consequently, the fluid leaked through the pores.

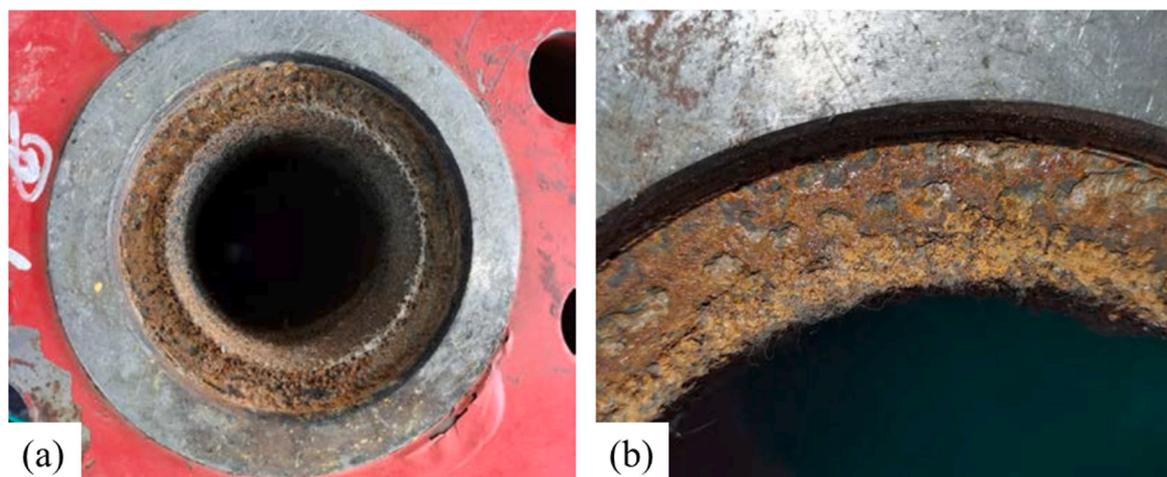
Fig. 8. Macroscopic image of the corroded ASTM A105 flange; (a) corroded sealing groove; (b) magnified corroded sealing groove<sup>5</sup> (Ji et al., 2023).

In a study by Ji et al. (2023), it was noted that corrosion was identified on the inner wall and sealing groove end face of a surface pipeline flange after a year of operation in a western Chinese oilfield. Failure analyses indicated that the flange's chemical composition and mechanical properties complied with the specified parameters. The primary reason for the corrosion observed was attributed to CO<sub>2</sub>-induced corrosion. Furthermore, the elevated temperature and the high flow rate of the medium significantly accelerated the corrosion process. The corrosion of the sealing groove end face, on the other hand, was a result of galvanic corrosion, with the difference in corrosion potential between the flange and gasket being the principal factor driving this phenomenon. The corroded sealing groove of an ASTM A105 carbon steel flange is depicted in Fig. 8(a), while Fig. 8(b) displays a magnified image of the corroded area.

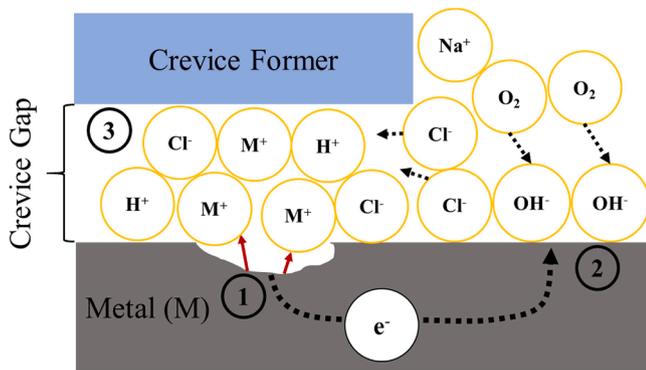
Fig. 9. Illustration of the crevice corrosion, depicting oxygen depletion and acid formation within the crevice in three steps according to CCS theory: 1- the metal (M) is oxidized to ( $M^+$ ), 2- oxygen ( $O_2$ ) is reduced to hydroxide ion ( $OH^-$ ), 3- the metal chloride (MCl) hydrolysis in seawater and forms metal hydroxide (MOH), hydrogen ions ( $H^+$ ), and chloride ions ( $Cl^-$ ).

Two mechanisms of crevice corrosion are identified in the literature; these are critical crevice solution (CCS) theory and IR drop theory (Kennell et al., 2008; Shojaei et al., 2019). According to the CCS theory, the crevice corrosion mechanism constitutes of two stages; in the first stage, anodic and cathodic reactions occur according to Eqs. (1) and (2), respectively. In Eq. (1), the metal  $M$  (e.g., iron) is dissolved in aerated seawater and oxygen will be reduced to hydroxide ion, as shown in Eq. (2). Fig. 9 shows a schematic illustrating the components involved in crevice corrosion. These components include the crevice former, responsible for creating a specific crevice gap on the metal surface. Each equation corresponding to the reactions is indicated by numbers in Fig. 9. Number (1) indicates the occurrence of oxidation as per Eq. (1) taking place on the metal surface within the crevice, while number (2) indicates the occurrence of reduction as per Eq. (2) taking place on the

In the second stage, oxygen concentration decreases over time since species exchange is restricted in the crevice. According to Fig. 9, the absence of oxygen in the crevice gap causes chloride ions to move to the crevice (shown by arrows on the  $Cl^-$  ion) to react with an excess positive charge of  $M^+$  and balance the electric charge. Afterwards, the metal chloride (MCl) hydrolysis in water (as stated by Eq. (3)) reacts to give undissolved metal hydroxide and acid. In Fig. 9, number (3) indicates that the reaction as per Eq. (3) taking place within the crevice. Raising the concentration of hydrogen ions and chloride ions accelerates the corrosion rate of metal; furthermore, the higher corrosion rate provides more  $M^+$  ions, and consequently, the amount of acid increases, so this process is autocatalytic. In cases where a passive layer forms on the metal surface, high  $H^+$  and  $Cl^-$  concentrations damage the passive layer and drastically increase the corrosion rate. Crevice corrosion is a localized corrosion, since during the time that the metal is being corroded aggressively, the reduction reaction constantly occurs on the exterior surface, so the outer surface of the crevice is protected (Costa et al., 2023).

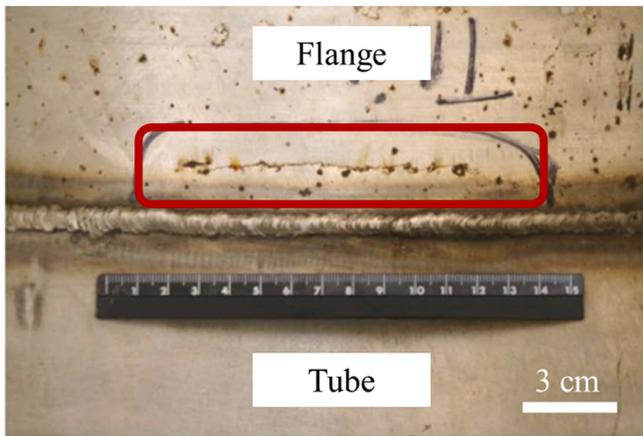
Fig. 10. Severe pitting corrosion observed on the internal side of the SDSS flange near the flange and tube connection, highlighted by the red rectangle<sup>6</sup> (adapted from Tavares et al., 2018).

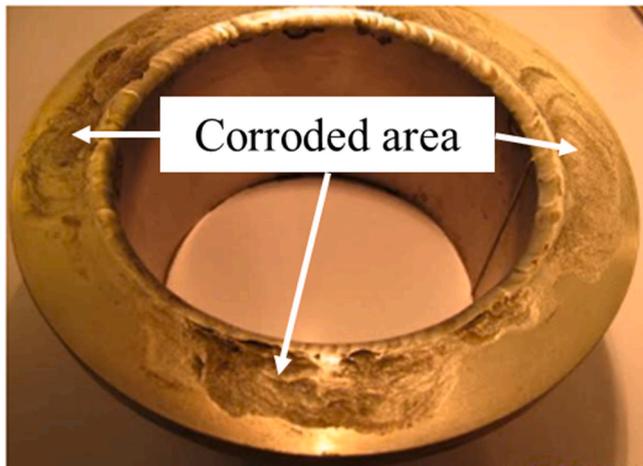
Fig. 11. Crevice corrosion (locations indicated by the arrows) on the face of a UNS31254 SS flange<sup>7</sup> (adapted from Bengtsson, 2015).

When two dissimilar metals are in contact with each other and immersed in a corrosive solution, the metal having a higher potential behaves as a cathode, and the other metal acts as an anode, resulting in the flow of electrons between them (Hack, 2016). Galvanic corrosion, due to its relatively high corrosion currents, could accelerate the flange surface corrosion in cases where graphite containing gaskets are used in combination with flanges (Francis and Byrne, 2007). Graphite exhibits a high level of nobility compared to most metals when exposed to seawater (Francis, 1994). Consequently, it has the potential to induce corrosion, even in the case of high-alloy materials, particularly within crevices. Sheet-type gaskets, such as flexible graphite, are frequently employed in situations involving smaller diameters, low pressures, or lower temperatures. However, as the diameter, pressure, or temperature rises, sheet gaskets become less appropriate due to the heightened risk of blowout. In such cases, semi metallic or metallic gaskets are employed as a solution (Bouzzid and Das, 2023). Bengtsson (2015) reported flange face corrosion in brackish water inside a cooling system of backup diesel generators. The flange material used in this system was UNS31254 SS, and a graphite-containing gasket was used to seal the joint. The high potential difference between the gasket and flange material accelerated the crevice corrosion on the flange surface, as is illustrated in Fig. 11.

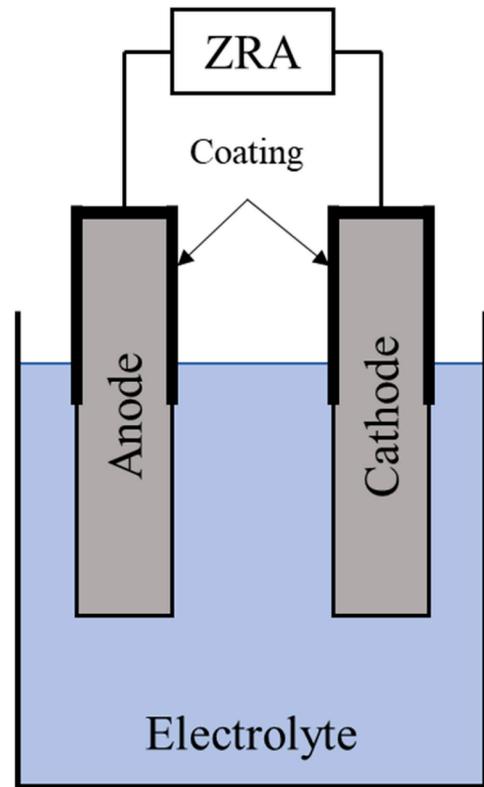
Fig. 12. Schematic of the galvanic corrosion test setup to measure the galvanic current between a partially coated anode and cathode, connected to each other by a zero resistance amperemeter (ZRA) and immersed in an electrolyte.

The ASTM G71 standard method proposes another method for conducting and evaluating galvanic corrosion tests in different electrolytes (ASTM G71-81(2019) 2019). The galvanic current is measured with a “zero resistance” amperemeter (ZRA), practically having a very low resistance. Such instrument measures the current between two electrodes by short-circuiting them. Fig. 12 presents a schematic illustration of a galvanic current measurement by using electrodes (anode and cathode) partially immersed in an electrolyte and short-circuited by a ZRA. Typically, a coating is applied on both electrodes to ensure a well-defined electrode surface area exposed to the electrolyte. It should

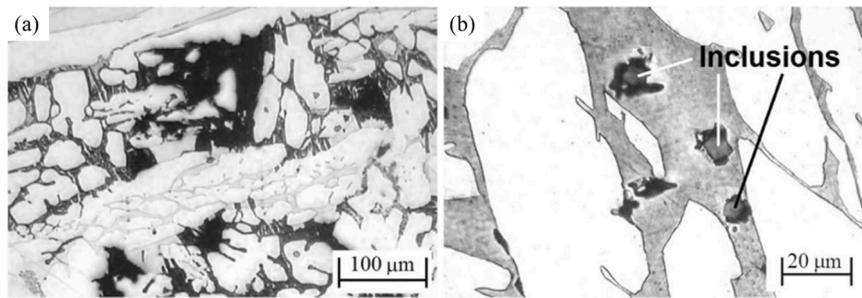
Fig. 13. Observation of pitting after polarization testing (a) region of the high density of  $\sigma$  phase (b) pit nucleation in non-metallic phase<sup>8</sup> (Tavares et al., 2018).

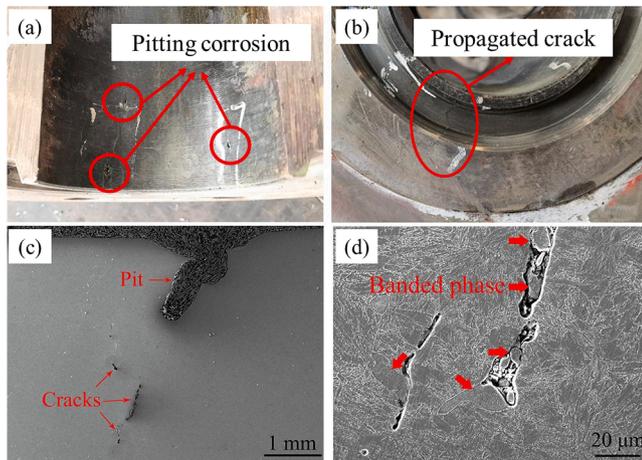
Fig. 14. Corrosion and propagation of cracks on the surface of the pipe flange can be observed as follows: (a) pitting corrosion occurring near the flange end on the inner surface; (b) crack propagation originating from the pit located in the ring groove; (c) the detailed cross-sectional morphology of the region affected by pitting and cracking; (d) a closer examination at a higher magnification<sup>9</sup> (adapted from Long et al., 2022).

In a study conducted by Long et al. (2022), it was observed that UNS S42000 SS(13Cr) pipe flange exhibited leakage after being in service for 23 months in an ultra-deep high-pressure and high-temperature gas well. This leakage was attributed to pitting corrosion on the inner wall of the flange, leading to the propagation of a crack towards the ring groove. The corresponding illustrations, Fig. 14(a) and (b), depict this situation. Additionally, Fig. 14(c) shows the cross-sectional appearance of the pitting and cracking area near the flange end, while Fig. 14(d) shows that the crack propagated alongside the banded phase. The banded phase is known as delta ferrite, which forms during the forging process at higher temperatures than the austenitizing temperature. The presence of this delta ferrite proved to be a significant factor in the failure of the

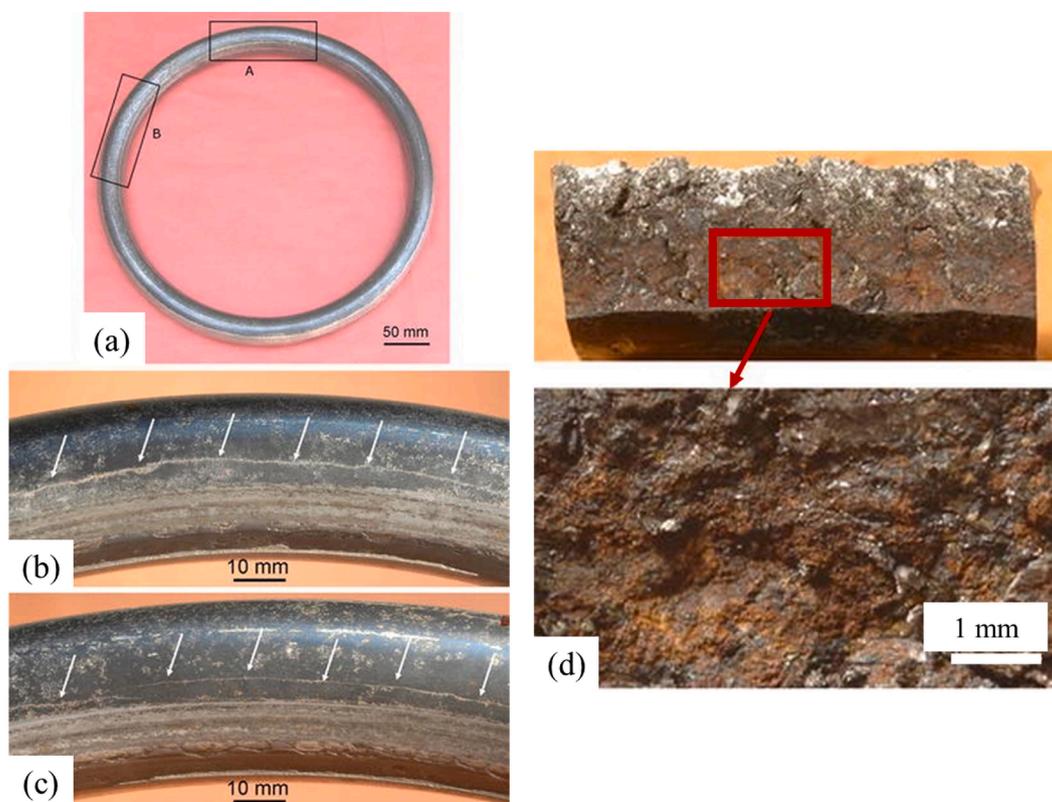
**Fig. 15.** Ring gasket: (a) overall view of the failed gasket; (b) and (c) close-up views of regions A and B, which reveal cracks; (d) fracture surface of the ring gasket displaying a thick layer of oxides and/or corrosion products<sup>10</sup> (adapted from Gore et al., 2014).

the graphite gasket was lower than for the others, and, in addition, crevice corrosion propagated after initiation with the graphite gasket, while causing repassivation in the cases of polymer and spiral wound gaskets. Stress corrosion cracking (SCC) in a ring type joint (RTJ) caused failure of reactor pipeline of a hydrocracker unit; the ring gasket was made of 347 SS. Examinations showed that the ring gasket had developed a number of discrete cracks as shown in Fig. 15(a), (b), and (c). Fig. 15(d) depicts the corrosion products firmly adhering to the fracture surfaces (Gore et al., 2014). Simonton and Barry (2006a; 2006b) embarked on the development of an innovative gasket design that

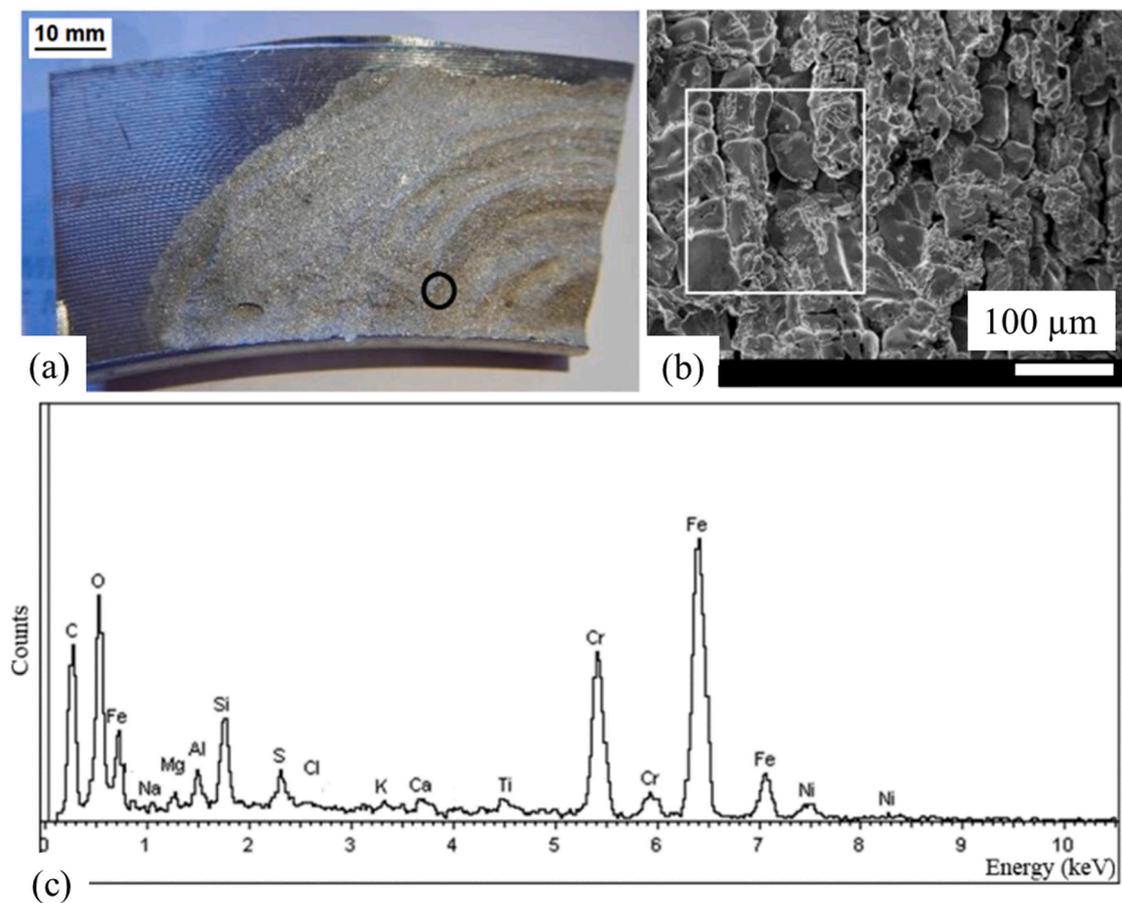
**Fig. 16.** Analysis of the corroded flange face: (a) the selected region of the corroded surface for SEM analysis; (b) SEM image of the circled region; (c) EDS analysis<sup>11</sup> (adapted from Kölblinger et al., 2022).

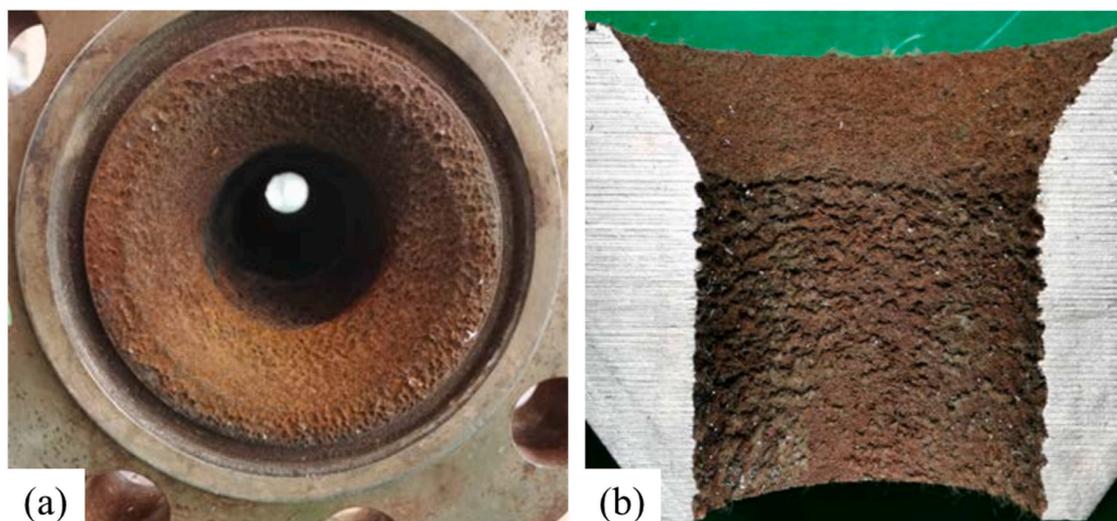
Fig. 17. Macroscopic image of the corroded ASTM A105 flange; (a) corroded sealing groove and inner wall; (b) cross section of the corroded flange<sup>12</sup> (Ji et al., 2023).

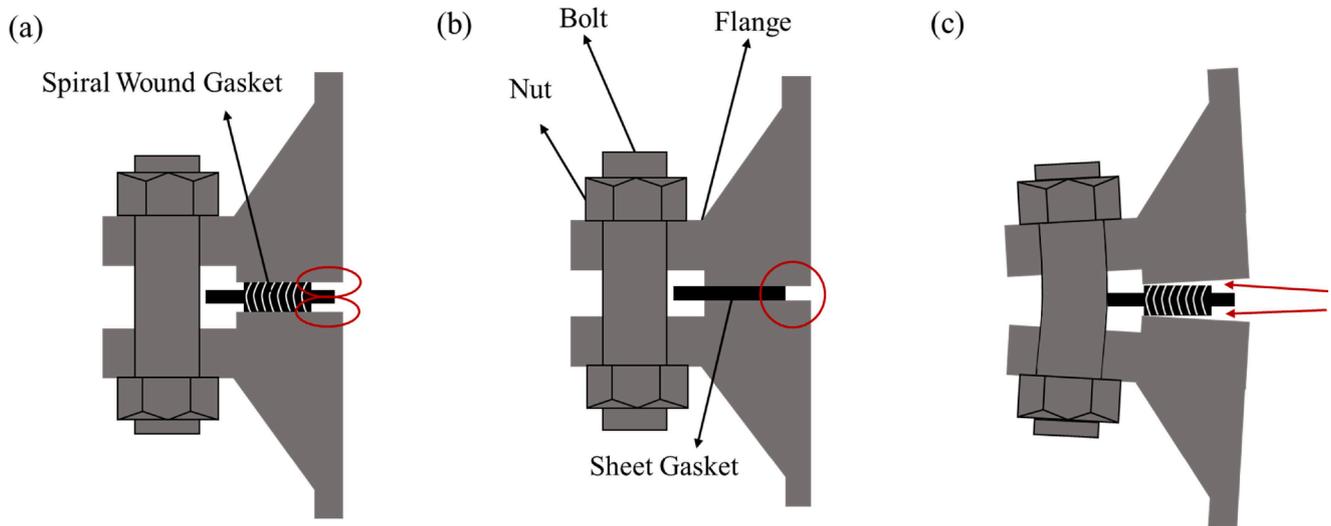
Fig. 18. Schematic of vulnerable places for crevice corrosion between gaskets and flanges: (a) standard spiral wound with inner ring-crevice at ID; (b) standard cut-sheet gasket-crevice at ID; (c) crevices above and below spiral wound inner ring (Worden, 2014).

Gaps or crevices between flanges due to the presence of the gasket are potential places for crevice corrosion to take place. Fig. 18 indicates

potential locations for crevice corrosion when using spiral wound and sheet gaskets. There is a gap between the inner ring and the pipe bore Fig. 18(a) and (b)), and the upper and lower zones of the inner ring of spiral wound gaskets which are susceptible to crevice corrosion (Fig. 18 (a)) (Worden, 2014). Fig. 18(c) illustrates the distribution of bolt load along the outer diameter (OD) of the flange, resulting in bending around the bolt circle and causing the flange to lift off from the inner diameter (ID) of the gasket. This phenomenon creates potential gaps that can facilitate the occurrence of crevice corrosion. The zones described with a circle in the flange face near the gasket inside diameter are crevices containing small amounts of stagnant fluid. A high rate of metal dissolution occurs in these crevice regions according to the mechanism discussed in the crevice corrosion section. After a period of time, enough mass loss occurs enlarging the crevice zone toward the outside causing failure by creating a leak path in the flange facing (as shown in Fig. 19). Creep in bolted flanged joints is a phenomenon where the bolts and the flange components deform over time due to the influence of mechanical

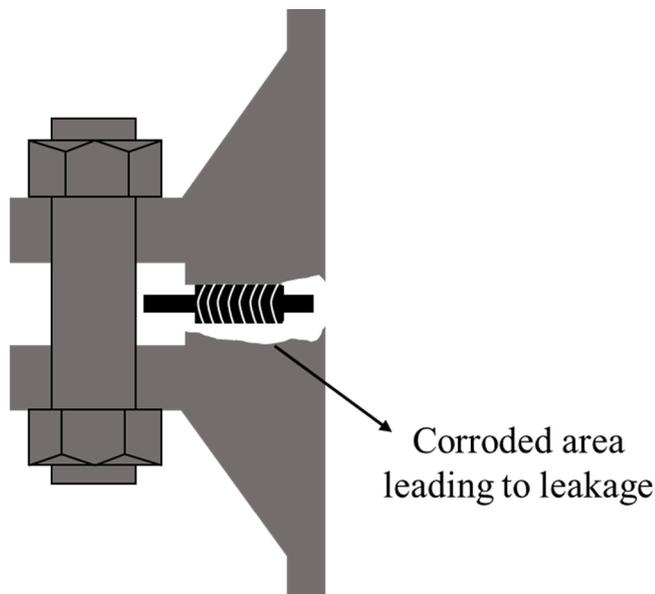
Fig. 19. Schematic illustration depicting crevice corrosion on the flange face at the interface between the flange and the standard spiral wound gasket, resulting in leakage (Worden, 2014).

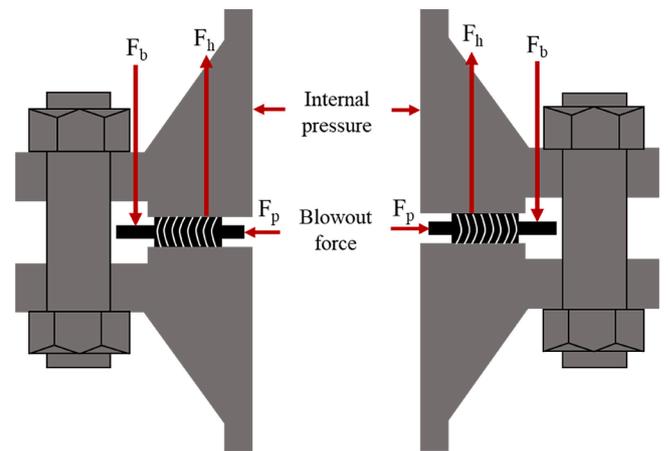
Fig. 20. Illustrative diagram depicting the mechanical forces applied on the gasket in action. The red arrows identify each force, including the compressive force generated by tightening the bolts ( $F_b$ ), the hydrostatic force ( $F_h$ ), and the blow out force ( $F_p$ ).

Corrosion on the flange surface or gasket can result in surface irregularities and inadequate compression force, thereby increasing the risk of leakage. In Fig. 20, the diagram illustrates the forces acting on gaskets in a bolted flanged joint (Tawancy, 2019). Prior to pressurizing the system, the gasket experiences a compressive force ( $F_b$ ) generated by tightening the bolts, effectively compressing the gasket into the flange to establish a seal and prevent fluid leakage between the flanges. Once the system is pressurized, opposing forces come into play: the hydrostatic force ( $F_h$ ), which seeks to separate the flanges, and the blowout force ( $F_p$ ), which aims to displace the gasket. To counteract the combined impact of the hydrostatic force and the blowout force, additional bolt tightening is required to maintain the gasket in position. However, excessive compression force, beyond what is necessary to counteract these opposing forces, may eventually lead to gasket deformation. Furthermore, non-uniform preload can introduce localized variations in gasket stresses. Taking these forces into consideration, the corrosion process can intensify the hydrostatic and blowout forces, leading to the unloading of the preload and, ultimately, causing leakage. As per the literature, corrosion affecting the outer ring of the spiral wound gasket (made of carbon steel) can diminish the gasket resistance to blowout forces. Furthermore, the corrosion of carbon steel flange faces may induce the expansion of corrosion products, potentially opening the flanges apart and relieving the compressive stress on the sealing element, ultimately resulting in leakage (Hamblin and Finch, 2001).

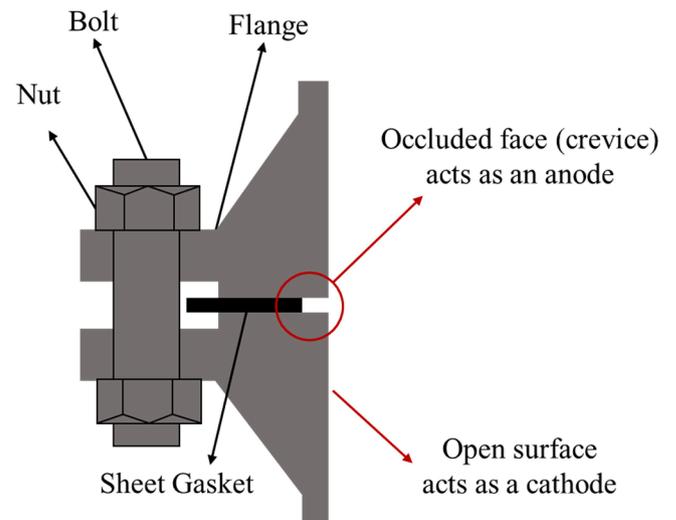
Fig. 21. Illustration of crevice corrosion in bolted flanged gasketed joints, highlighting the anode and cathode regions.

As shown in Fig. 21, in flanged joints, there are two surfaces: the occluded face, which is the surface facing the gasketed joint, and the open surface. The occluded face typically acts as an anode for those alloys that are passive, while the open surface acts as a cathode, except in cases where the gasket is a nobler material (e.g., graphite). The extent of oxidant presence and its accessibility to the open flange surface are critical factors influencing the anodic dissolution reaction within the crevice, ultimately leading to an increased rate of crevice corrosion. What makes crevice corrosion notably challenging is the contrasting availability of oxygen, or other oxidants. Oxygen is often more abundant on the open flange surface, where it can facilitate the formation of a protective oxide layer.

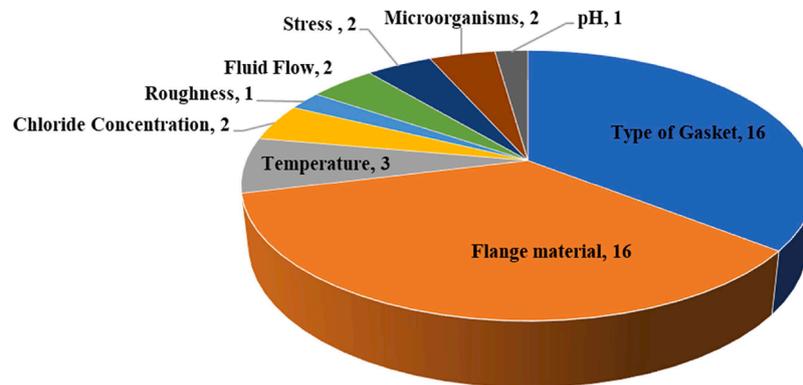
Fig. 22. Studied factors in papers examined flange corrosion in bolted flanged joints.

The distribution and fraction of the studied factors in the field of corrosion phenomena in bolted flanged systems are presented in Fig. 22 to better understand the most important failure factors and the factors that are understudied in the literature. Most of these studies investigated the material of the flange and the type of gasket. As well, it can be concluded that SSs and nickel-based alloys dominated the studied flange
