# Characterization of Subsurface Microstructural Alterations Induced by Hard Turning of Inconel 718

Heithem Touazine, Kanwal Chadha, Mohammad Jahazi, and Philippe Bocher

Conventional machining especially hard turning is commonly used in aerospace industry to produce the final shape of cylindrical parts. However, the process generates damages and microstructural alterations on the surface and at the subsurface layer, in particular the cracking of hard carbides particles. The present paper focuses on investigating the probable mechanisms responsible for carbide cracking and the formation of a softened layer at a depth between 10 and 30  $\mu\text{m}$  below the machined surface. Advanced techniques, such as laser confocal microscopy and field emission gun scanning electron microscope equipped with in situ picoindenter and electron backscatter diffraction, were used to characterize and analyze the evolution of the microstructure in the affected layer and propose the possible governing mechanisms for the observations.

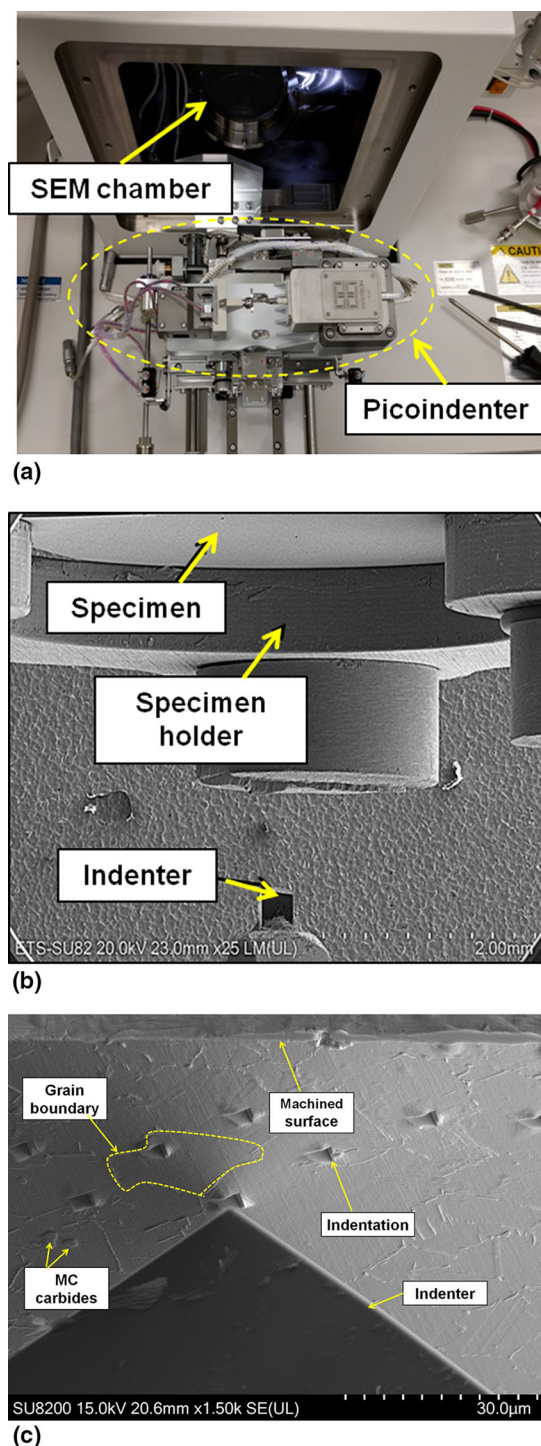
**Fig. 1** Hysitron PI 88 SEM picoindenter: (a) plugging of the picoindenter inside SEM chamber, (b) indentation and imaging at real time and (c) nanoindentation performed at the real time allowing us to avoid hitting (Ti, Nb) C carbides

Nanoindentation tests were performed using Hysitron PI 88 SEM Picoindenter plugged inside scanning electron microscope chamber, as shown in Fig. 1(a) and (b). A single indentation was applied in each grain as illustrated in Fig. 1(c). For each depth, an average of five measurements for hardness and displacement was taken. The indentations were performed with 15 mN load, 5 s charging time, 5 s holding time and 5 s discharging time, as shown in Fig. 2.

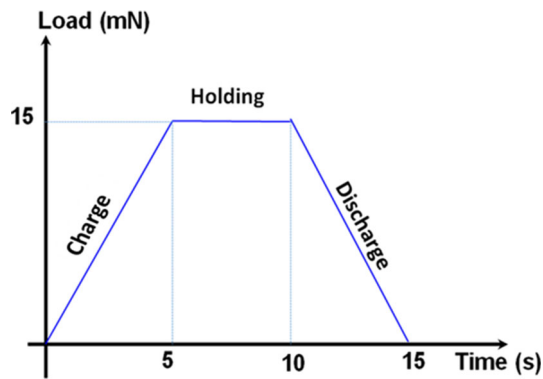
Fig. 2 Performed nanoindentation cycle

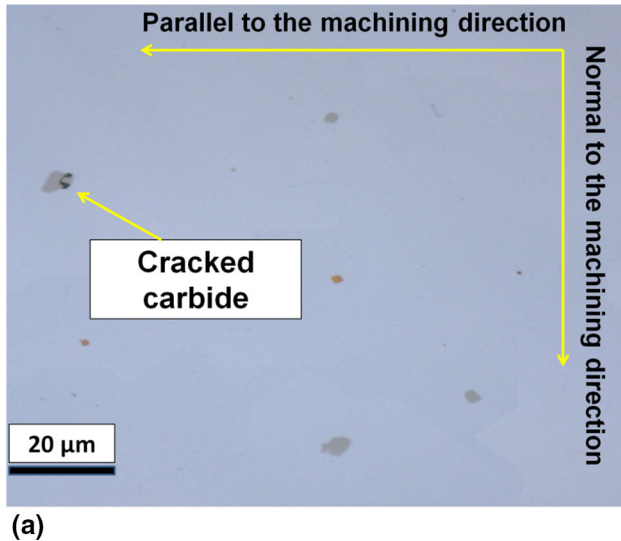
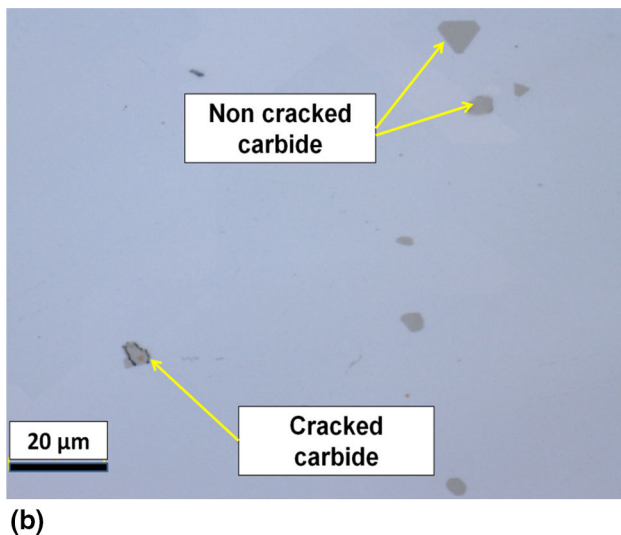
Fig. 3 Different types of cracked carbides in the as-received material

The as-received material contains 2.6% of cracked oriented randomly through the microstructure, as shown in Fig. 3(a) and (b). The major causes of cracks are deformation during forging of the ingots or heat treatments, as also reported by Texier et al. (Ref 33). A previous work indicated that the amount of cracked carbides increases with increasing material removal rate and deformation energy during machining of Inconel 718 (Ref 31).

Observation of the cracked carbides in the subsurface region showed that almost all the cracks had a  $45^\circ$  angle with the machined surface (i.e., the horizontal line). This is in contrast to those in the as-received material, which did not show any preferential orientation, as indicated above and shown in Fig. 3(a) and (b). This finding suggests that the deformation of the material during machining brings the larger precipitates to cleave under the maximum resolved shear stress ( $45^\circ$ ) due to the large difference of deformation path between the top and the bottom of the carbides. On the other hand, the smaller carbides flow with the deformed matrix and therefore do not necessarily crack. Agrawal et al. (Ref 41) and Lee (Ref 42) reported

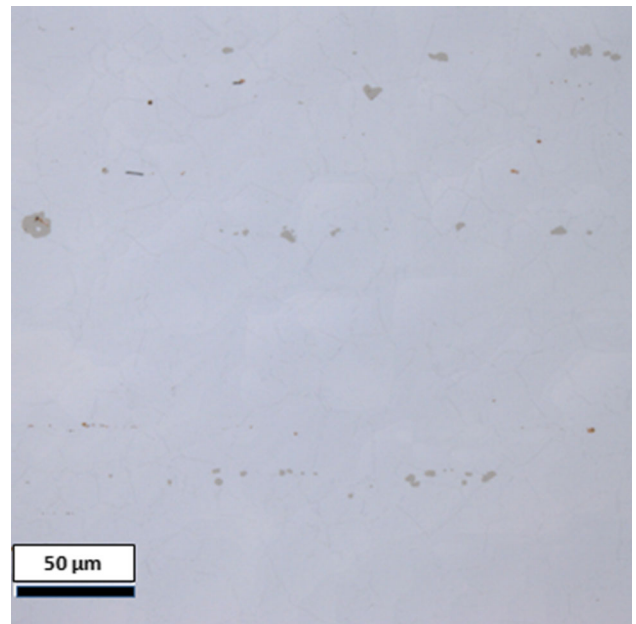
Fig. 4 Different sizes of carbides in the as-received material with 50 $\times$  magnification lens

In addition, the microstructure presents different sizes of (Ti, Nb) C carbides, as shown in Fig. 4. To draw a representative distribution of carbide size of the studied material, more than 6000 carbides were analyzed using image analysis technique

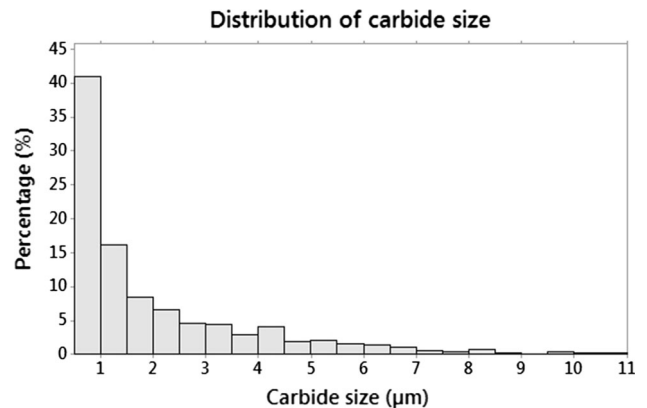
Fig. 5 Carbide size distribution in the microstructure of Inconel 718

with a lens of 50 $\times$  magnification. The results indicated that 76% of carbides were less than 3  $\mu\text{m}$ , as shown in Fig. 5. It should be mentioned that in a previous study (Ref 31) it was shown that the amount of cracked carbides changed with changing the cutting parameters. In the present study, the possible mechanisms responsible for the formation of cracked

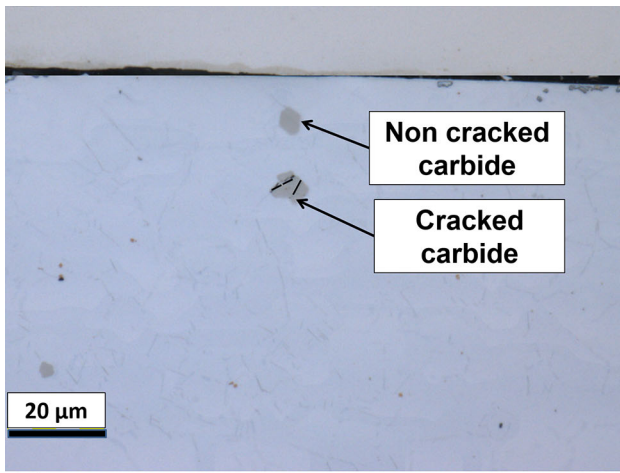
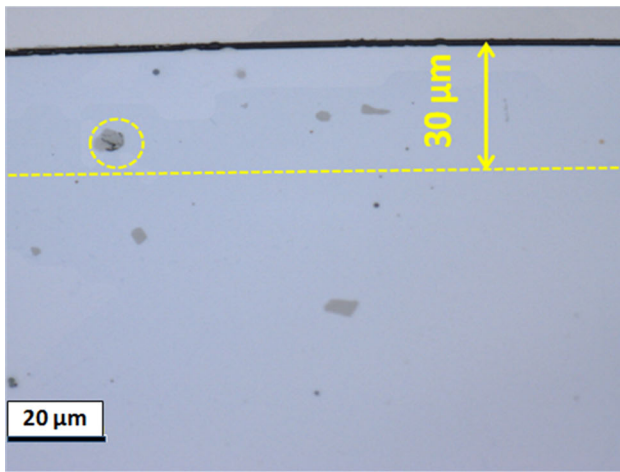
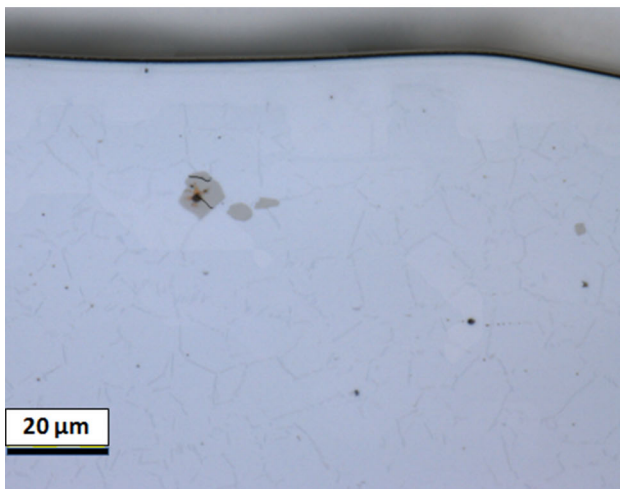
**Fig. 6** Example of cracked carbides after machining of Inconel 718: (a) maximum depth of the analyzed surface, (b) typical cracked carbide located at 23  $\mu\text{m}$  beneath the machined surface and (c) large-sized carbides are easier to fracture

Optical microscopy was used to distinguish between cracked and non-cracked carbides under different finishing cutting conditions, as presented in Fig. 6(a), (b) and (c). The related cutting conditions [i.e., cutting speed  $V_c$  (m/min), feed rate  $f$  (mm/rev) and depth of cut DoC (mm)] are presented in Table 2. In general, the analyses showed that carbides comprised between 0.5 and 3  $\mu\text{m}$  were not cracked.

The thickness of the deformed layer was measured from the surface to the last distorted grain boundary and to the last defect, including cracked carbides. To this end, at least five measurements were taken and the average was taken and used in the analysis. Microscopic examination of the subsurface layer did not reveal any specific distribution of carbides, whether cracked and non-cracked ones. Figure 6(a), (b) and (c) shows some illustrative examples, where it can be seen that the cracked carbides are below the non-cracked one (Fig. 5(a), while in Fig. 6b, the cracked carbide is seen below few non-

cracked ones with a size less than 3  $\mu\text{m}$ , and lastly, in Fig. 6(c) the cracked carbide is seen above all non-cracked ones. Thus, there is no consistency in the presence of cracked carbides with

respect to the depth beneath the machined surface. Also, the microscopic analysis indicated that the majority of the cracked carbides were located in a depth comprised between 12 and 23  $\mu\text{m}$  beneath the machined surface for different cutting conditions as shown in Fig. 6(a), (b) and (c). A similar behavior was found by Ranganath et al. (Ref 34) and by Guo and Anurag (Ref 35). They explained that the carbide cracking occurs simultaneously with the rotation along the cutting direction during material removal process for the large-sized carbides, whereas small carbides flow with the material and rotate along the cutting direction without cracking.

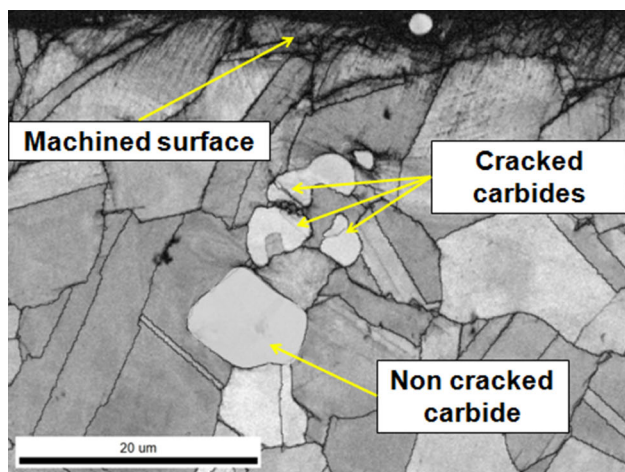
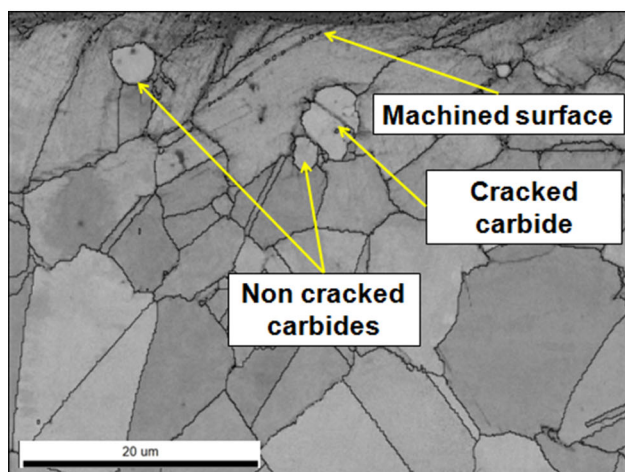
**Fig. 7** IQ images of machined Inconel 718 surface showing the presence of cracked and non-cracked carbides

Figure 7(a) and (b) shows the image quality (IQ) maps of two random locations of machined Inconel 718 sample. The black lines in the images denote high-angle grain boundaries (HAGB,  $\theta > 15^\circ$ ). The machined surface can be seen in the top region of the IQ map which is concentrated below 10  $\mu\text{m}$  of the surface. The IQ maps depict a clear visualization of the presence of carbides located in the subsurface layer. Using EBSD technique, grains and carbides could be distinguished based on the crystallographic structure and lattice parameters (Ref 36). The presence of cracked carbides along with the non-cracked ones can be seen very clearly. Similar observations are shown in Fig. 6(a), (b) and (c) where cracked carbides were visible at different depths and locations. IQ maps provide a very clear image of cracks and grains and their misorientation relation with respect to the neighboring ones, as shown in Fig. 7(a) and (b). However, it is still difficult to predict the reason for the presence of cracked carbides along with the non-cracked ones with respect to the depth beneath the machined surface.

the uniform color of the grains around the circled carbide shown in Fig. 8(a). Furthermore, it can be observed that the carbides located at the grain boundaries are the ones which are easiest to be cracked, as shown in Fig. 7(b) and 8(b).

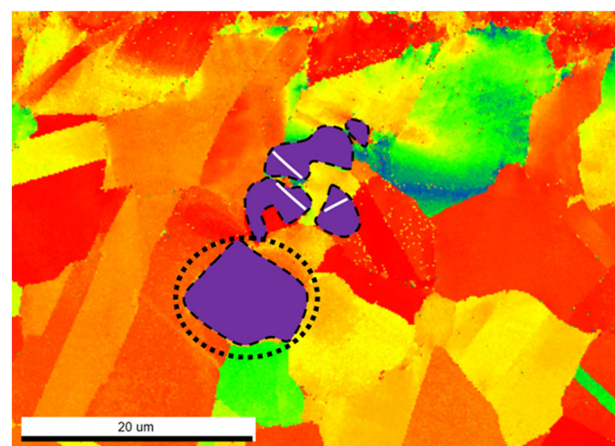
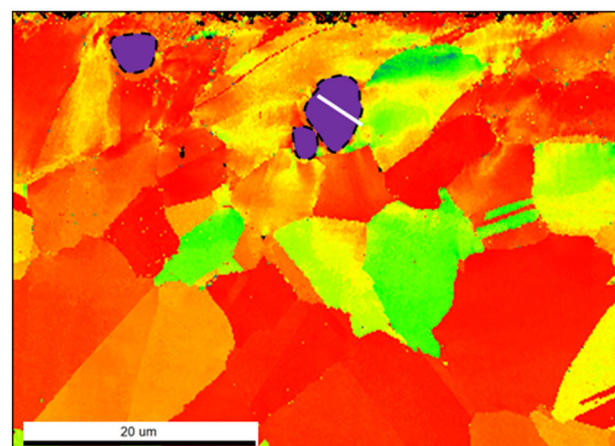
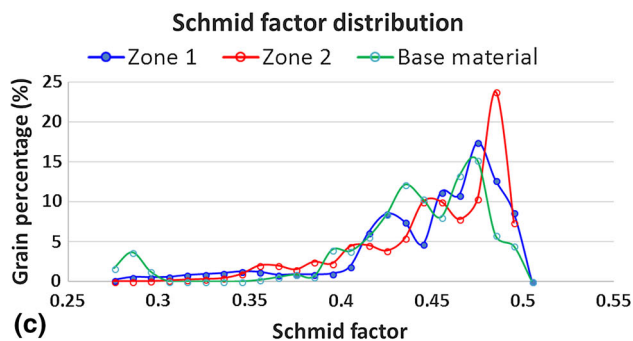
**Fig. 8** EBSD maps showing the distribution of the Schmid factor in the machined Inconel 718 in the compression direction: (a) zone 1, (b) zone 2 and (c) Schmid factor distribution for zone 1, zone 2 and base material

EBSD maps (Fig. 8) showing distribution of Schmid factor beneath the machined surface were generated by considering the direction of compression as perpendicular to the transverse direction of the machined sample. These maps represent high and low values of the Schmid factor which indicate that the grains are soft and hard, respectively (Ref 37). As illustrated in Fig. 8(a), (b) and (c), most of the grains in the as-received and the machined material have a relatively high Schmid factor of more than 0.4 and the distributions of Schmid factors were slightly different for the two zones of the same machined sample. In addition, Schmid factor maps showed that the grains in the affected layer by machining present a gradient of Schmid factor under the effect of deformation induced by machining. It was observed from the maps that the preferential location of crack initiation in the carbides was at the boundaries of grains which presented a gradient of Schmid factor. However, the carbide encircled in black in Figure 8(a) was not cracked probably because it was located outside the affected area by machining. It was surrounded with non-deformed grains which do not present a gradient of Schmid factor as demonstrated by

However, for some grains located near the machined surface the correlation between high Schmid factor and low dislocation density is not fully respected, as shown in Fig. 8(a) and (b) and

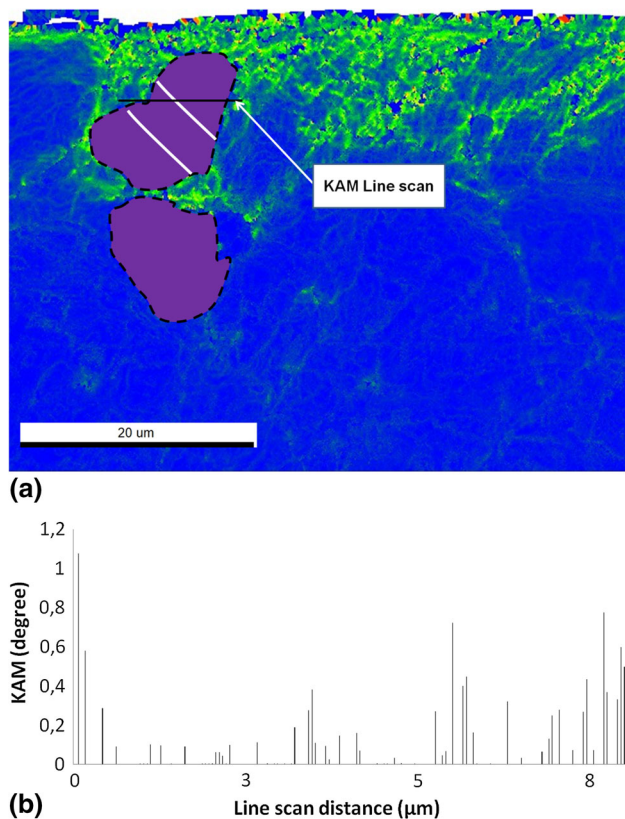
**Fig. 9** EBSD maps showing the high gradient of Schmid factor and KAM around the cracked carbides: (a) KAM map and (b) line scan KAM values

cracked carbide. The higher KAM around the carbide can lead to high stresses which ultimately result in the cracking of the carbide. A line scan was performed in the cracked carbide circled in black as shown in Fig. 9(a). Using line scan, KAM values were drawn from the left to the right as shown in Fig. 10(b). KAM values across the matrix/carbide interface indicated a significant presence of dislocations around the carbide. Also, we can conclude that the distribution of KAM in the matrix did not present a gradient around them, most likely because the material has recrystallized after the forging operation. It is different for the affected layer by machining.

seen. Likewise in Fig. 9(b), similar observation is made from the cracked carbide (encircled in black color), where the presence of two gradients can be observed, i.e., high KAM on the left side of the carbide and relatively low KAM on the right side but not within the carbide (shown with white arrows).

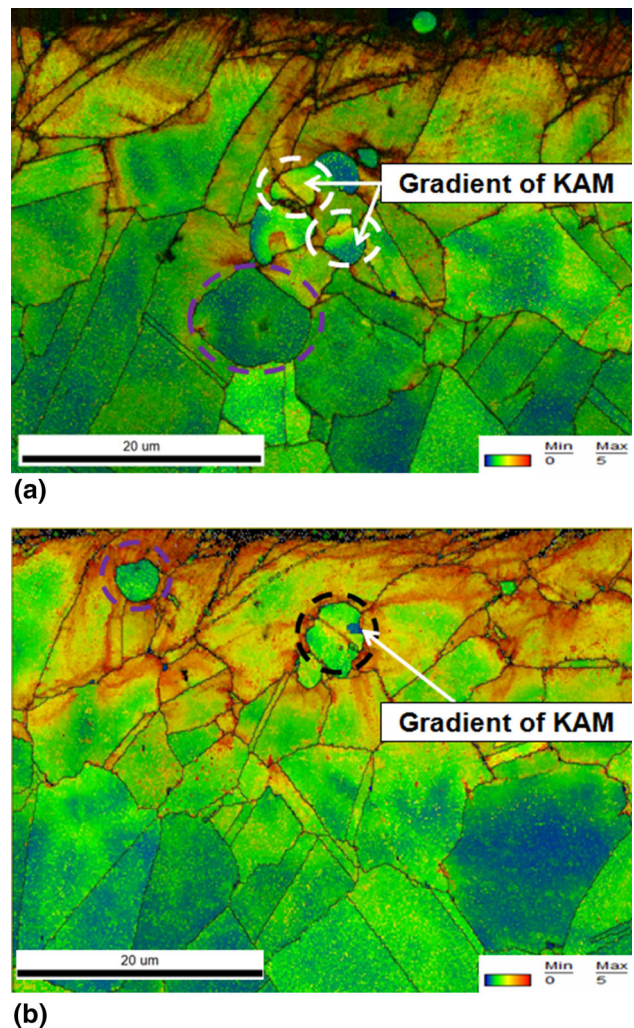
**Fig. 10** Kernel average misorientation maps of machined Inconel 718 samples

In this context, as also reported by Révilla et al. (Ref 43) KAM measurements can provide quantitative information about the dislocation density present in the matrix. The level of KAM (degree) within the grain gives the level of dislocation density in them. In the KAM analysis, higher is the dislocation density (or in other words strain), higher will be the KAM value (Ref 44, 45). Figure 10(a) and (b) shows the KAM maps of the random image of Inconel 718, where it can be seen that the KAM is higher near the machining surface, as compared to further depths. These results are similar to the ones reported by Zhang et al. (Ref 46) who found that KAM values were higher near the machined surface because of plastic deformation and were lower through the thickness. The present study shows that cracks on carbides appeared to be initiating at zones where the KAM gradient values were between 12 and 25 μm, i.e., higher dislocation density at the interface carbide/grain (Fig. 9a). The crack (encircled in white color) initiates from the left side of the carbide, which is red in color indicating high KAM, whereas on the right side of the grain, relatively low levels of KAM can be

The observations in Fig. 10(a) and (b) give a probable indication that the cracks are initiating when there is a sharp gradient of dislocation density at the edges of the carbides.

The proposed mechanism holds strong with the observation of the non-cracked carbides [encircled in violet in Fig. 10(a) and (b)] where the surrounding areas of these carbides do not show the presence of a KAM gradient or high Schmid factor values. However, a question could arise whether the high KAM value is a cause for carbide cracking or is a consequence of it. In a previous research (Ref 32), the present authors found high misorientations around carbides in non-deformed Inconel 718. Also, in a recent research, Graboulev et al. identified high-KAM regions as potential locations for microcrack initiation in steel samples submitted to fatigue testing (Ref 47). The above findings support the view that high KAM values could be the cause for carbide cracking in the investigated material.

and the plastic deformations induced during machining. The hardened region is characterized by intense deformation of grains and deflection of grain boundaries due to the tool pressure and material shearing. The 12  $\mu\text{m}$  thickness of the hardened layer was confirmed with the KAM maps which showed a high concentration of local misorientation represented in red color in Fig. 10(a) and (b).

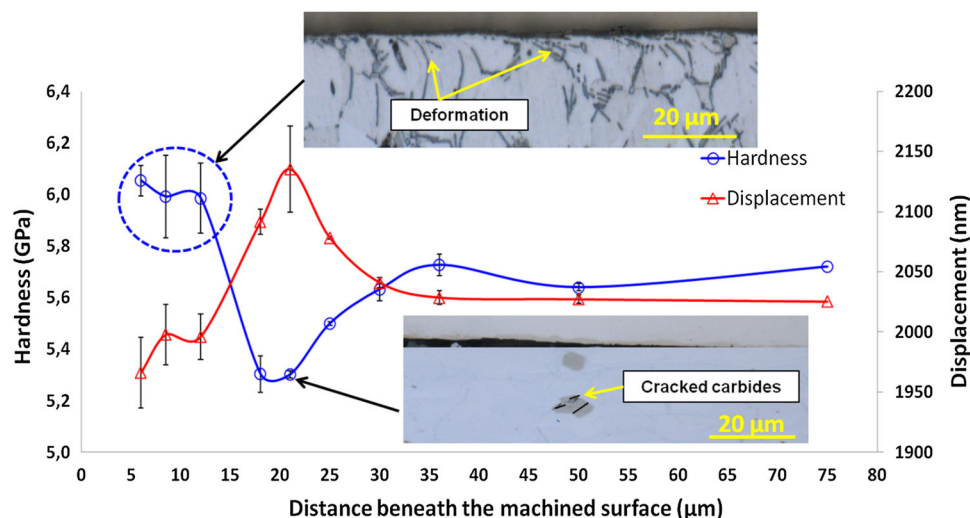
Fig. 11 Spoon-shaped curve showing the evolution of nanohardness beneath the machined surface of hard turned Inconel 718

Thanks to the picoindenter device, the (Ti, Nb) C carbides present in the microstructure of the Inconel 718 were avoided in order to measure the material hardness and to reduce the standard deviation of measurements. The results are reported in Fig. 11 where the hardness evolution is reported by the blue curve and the indentation depth with the red curve. The hardened layer has a depth of about 12  $\mu\text{m}$  and 0.4 GPa harder than the bulk material. The dispersion for the hardness values suggests a heterogeneous deformation throughout the machined surface, which may be related to different orientations and hardnesses of the grains in the as-received material. The hardness then drops, and a 10- $\mu\text{m}$ -thick layer softer than the bulk material with 0.35 GPa is observed. Simultaneously, the depth of the indentations (displacement) was measured. The obtained values confirm the presence of both a hardened layer and a softened layer with displacements of the order of 1980 nm in the first 12  $\mu\text{m}$  and of between 2050 and 2125 nm of depth between 12 and 23  $\mu\text{m}$ . This enhancement of hardness just below the surface is directly related to the work hardening

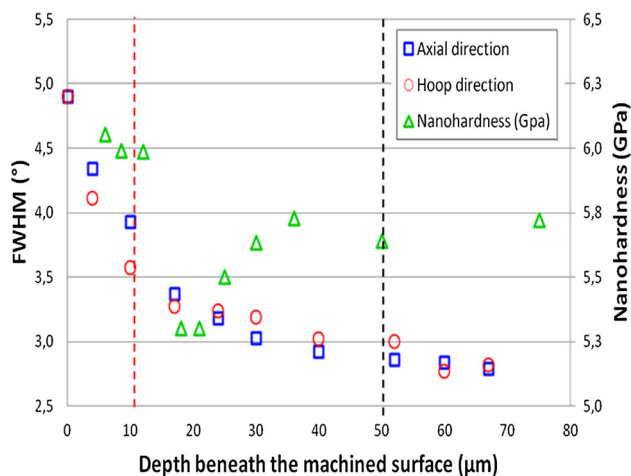
**Fig. 12** Nanohardness evolution in the subsurface vs. FWHM values

In order to evaluate the possible microstructural changes in the subsurface, the evolution of nanohardness versus full width at half maximum (FWHM) of XRD peak was examined, as shown in Fig. 12. The green color presents nanohardness evolution, and the blue and red colors present FWHM in axial and hoop directions, respectively. Nanohardness measurements showed a hard region in the first 12  $\mu\text{m}$ , then a soft region over a 30  $\mu\text{m}$  depth and then back to the base material hardness. FWHM values decreased significantly in the first 15  $\mu\text{m}$  due to the decreasing of dislocation density as confirmed by the KAM figures. Furthermore, FWHM became relatively stable at a depth of 35  $\mu\text{m}$ . On the basis of these results, it can be concluded that the softening could not be related to recovery (i.e., decreasing of dislocation density) in the 15-30- $\mu\text{m}$ -deep region.
