Chapter 6 **Durability of earth materials: weathering agents, testing** procedures and stabilisation methods

Abstract

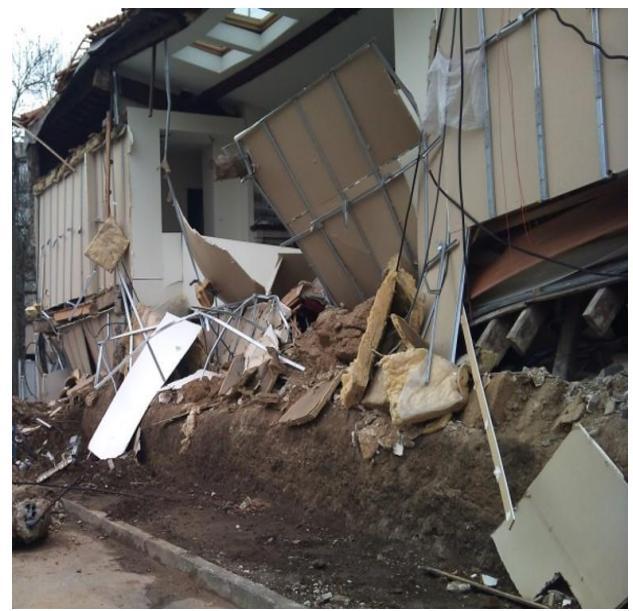
Figure 6-1 Collapse of an earth building in Lyon, France, due to the accumulation of humidity at the wall base.

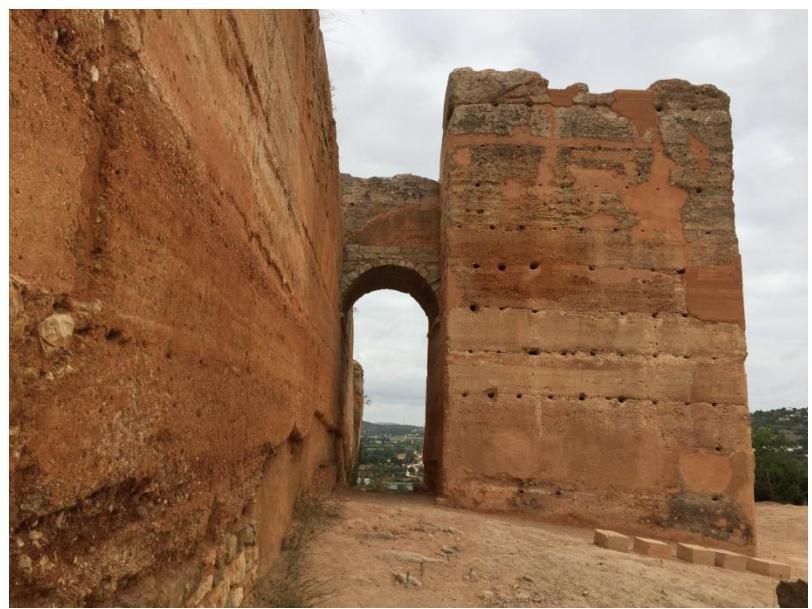
Figure 6-2 Paderne Castle in Algarve, Portugal, built in the 12th century by using earth stabilised with air lime.

For centuries, the water durability of raw earth has been enhanced through chemical stabilisation with cement or lime (e.g. Walker, 1995; Parracha et al. 2019a). An example of well-preserved ancient earth structure is Paderne Castle in Algarve (Portugal), which was built in the 12th century by using earth stabilised with air lime (Figure 6-2). Alternative stabilisers, including unusual options such as cow dung (Millogo et al., 2016) or plant aggregates (Laborel-Préneron et al., 2016), have also been employed to reduce environmental impact (Maskell et al., 2014).

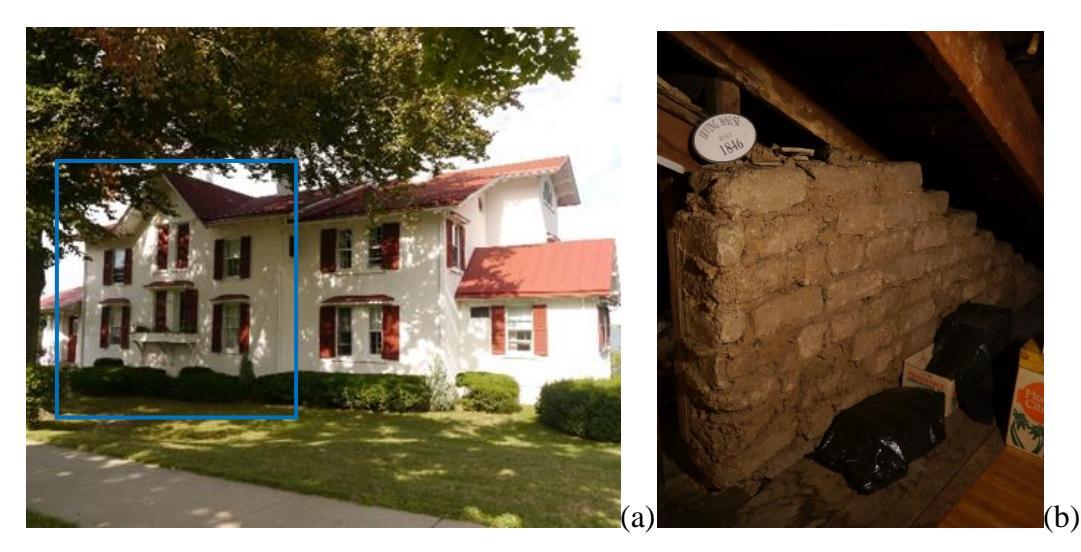
Figure 6-3 a) Irving House built in 1846 in Geneva, New York State, USA (the blue frame indicates the part built in adobe), b) adobe bricks in the attic of Irving House (Ricaud, 2014).

The effects of freeze-thaw cycles on earth buildings are here demonstrated by the analysis of two cases from the United States. The first case is the Irving House (Figure 6-3), which is located in the region of Geneva, New York. The National Centers for Environmental Information (2018) indicates that, in this region, the average high temperature is 14 °C while the average low temperature is 4 °C with extreme values of 35 °C and -22 °C. The Irving House was built in 1846 with unfired earth bricks made of clay, sand, gravel, organic matter and water (with a clay content ranging between 8% and 22%). The blue frame in Figure 6-3 indicates the part of Irving House that is made of adobe bricks. The external wall surface was protected with the typical render used in this region during the 19th century, which included one volume of clay, one volume of sand, one volume of lime, one volume of ash and half volume of beef blood together with fibres such as horsehairs or straw (Ricaud, 2014).

The climates of the above two regions are relatively similar and are characterised by the widespread occurrence of frost in the cold season. Yet, comparison of Figure 6-3 and Figure 6-4 indicates that the Irving House is relatively well-preserved, apart from some localised defects on the inner wall surface, while the Jackson-Einspahr House shows extensive signs of weathering. This difference may be due to the regular application of a protective render on the external wall surface of the Irving House, which was not the case for the Jackson-Einspahr House. The application of this protective coating significantly reduced the impact of freeze-thaw cycles on the underlying earth structure. The above observations emphasize the importance of the regular inspection of exposed walls in freezing climates, which is necessary

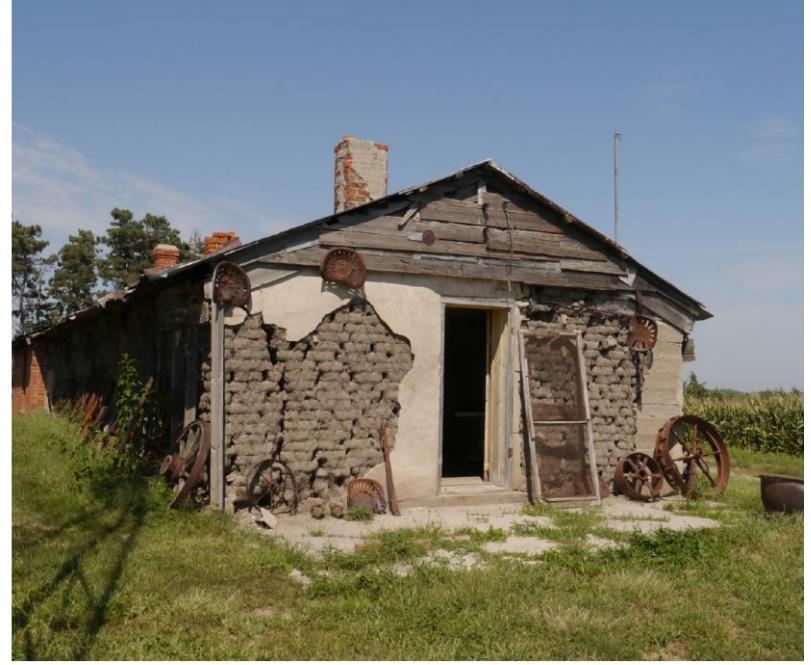
Figure 6-4 Jackson-Einspahr House built in 1881 in Holstein, Nebraska State, USA (Ricaud, 2014).

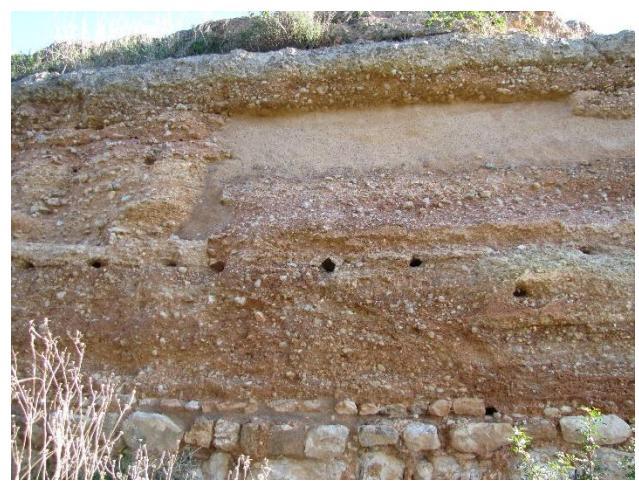
Figure 6-5 Erosion at the base of a rammed earth wall in Paderne Castle, Portugal.

China (Lian-You et al., 2003), the Alhambra palace in Spain (Fuentes-García, 2015) and the Paderne Castle in Portugal (Cóias and Costa, 2006). Figure 6-5 shows an example of the progressive erosion caused by the wind at the base of a rammed earth wall of the Paderne Castle. Due to the slow progression of damages, serious consequences can generally be avoided by applying a protective render on the exposed walls and/or by periodically replacing the eroded material (Gomes et al., 2016).

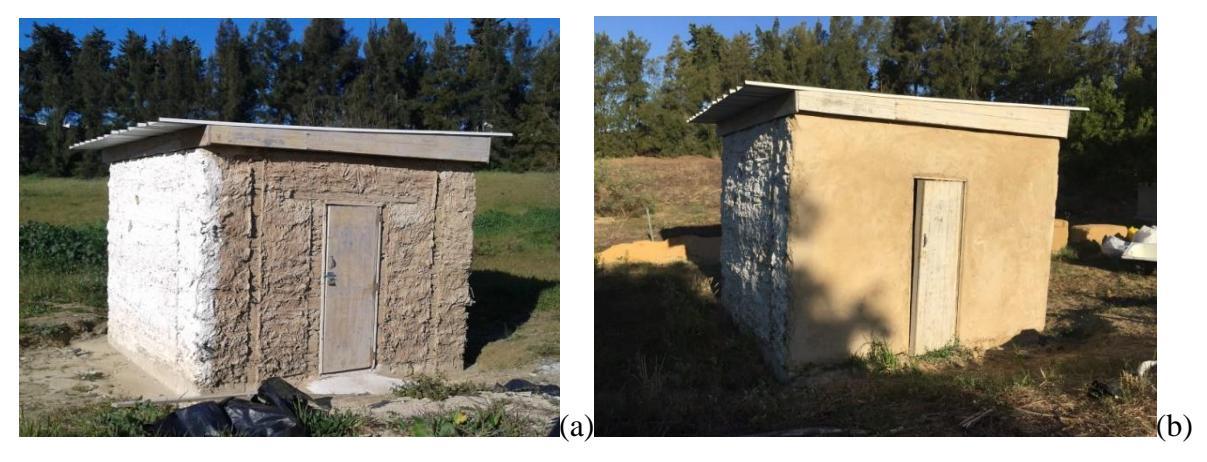
Figure 6-6 Reed-cob experimental cellule: a) shortly after construction with unrendered walls and b) five years after construction during the application of a protective render on the wall surface.

In 2014, a small earth building was erected in a semi-rural area 3 km from the Atlantic coast of Portugal (Figure 6-6), which is characterised by the prevalence of strong rains and winds from the South. The walls of the building were made of stabilised lightweight cob with reed fibres, lime putty and pozzolan. The walls were manufactured in a sequence of 10 cm cob lifts separated by layers of reeds, which were supported by a concrete foundation and covered by a thermally insulated roof. A detailed description of the wall material and building technology is given in Val et al. (2015) and Carneiro et al. (2016). The North and East walls of the building were left unprotected and directly exposed to the atmosphere, while the South and West walls were lightly protected by a lime wash (Figure 6-6a). The building was continuously monitored since construction and no sign of significant erosion were detected after 5 years, at which time the walls were rendered with an air lime stabilised earth mortar (Figure 6-6b).

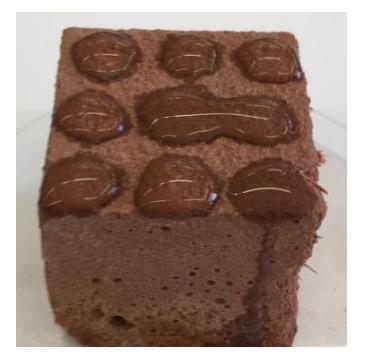
Figure 6-7 Water repellence of an earth mortar stabilized by microbially induced iron-oxide precipitation (MIIP) (Faria and Lima, 2018)

Finally, the utilisation of eco-friendly bio-products has also been recently considered as a possibility for improving the durability of earth plasters during the surface treatment of exposed walls. For example, MIIP has been employed by Parracha et al. (2019b) for the stabilisation of earth plasters resulting in a reduction of both moisture absorption and damage after contact with water (Figure 6-7).
